SQ-3185

HIXON 6.9km

2019 Inspection

| Crossing Name | Belknap Creek |

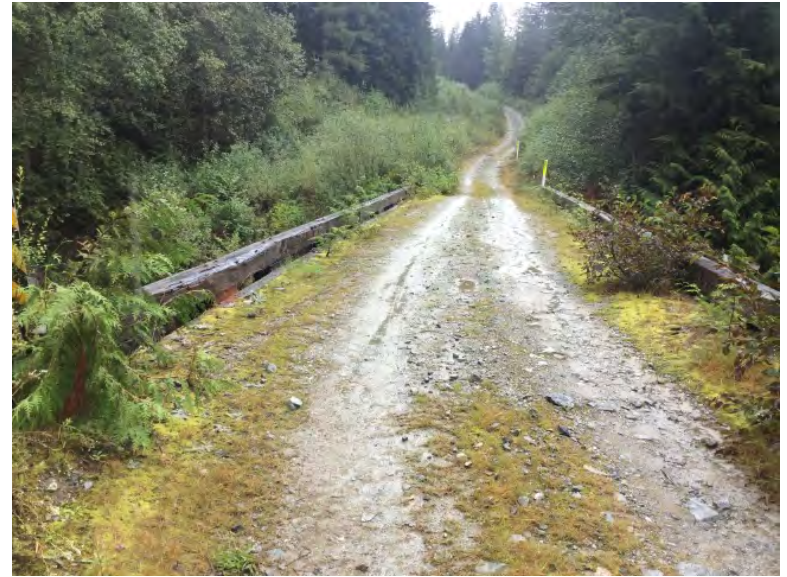
| Grout Pockets | Unrated | Gravel on deck |
| Deck Joints | Unrated | Gravel on deck |

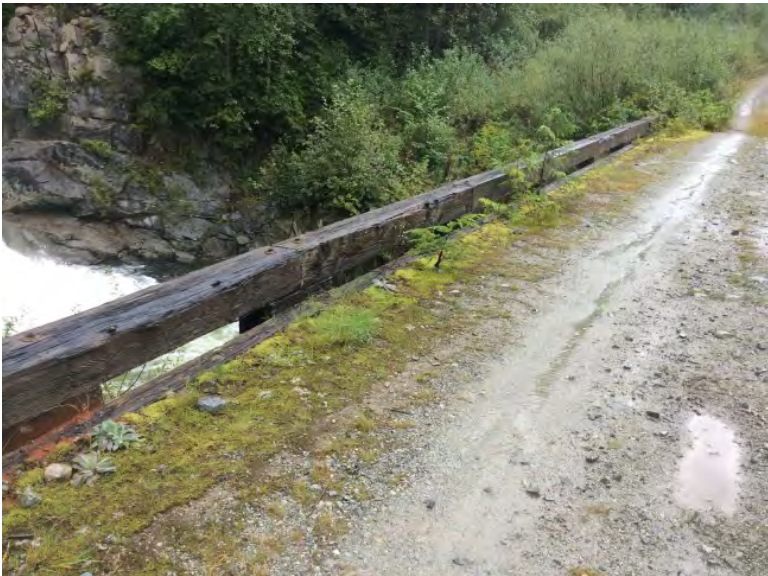
Guard Rail

| Curb Rail/Blocks/Posts | Poor | Rotting and loose curb rails |
| Overall Deck Condition | Poor | Rotting curb rails |

| Repair Item | Priority | Repair Description |
|---|---|---|
| 1 | High | Rotting curb rails to be replaced prior to industrial use |

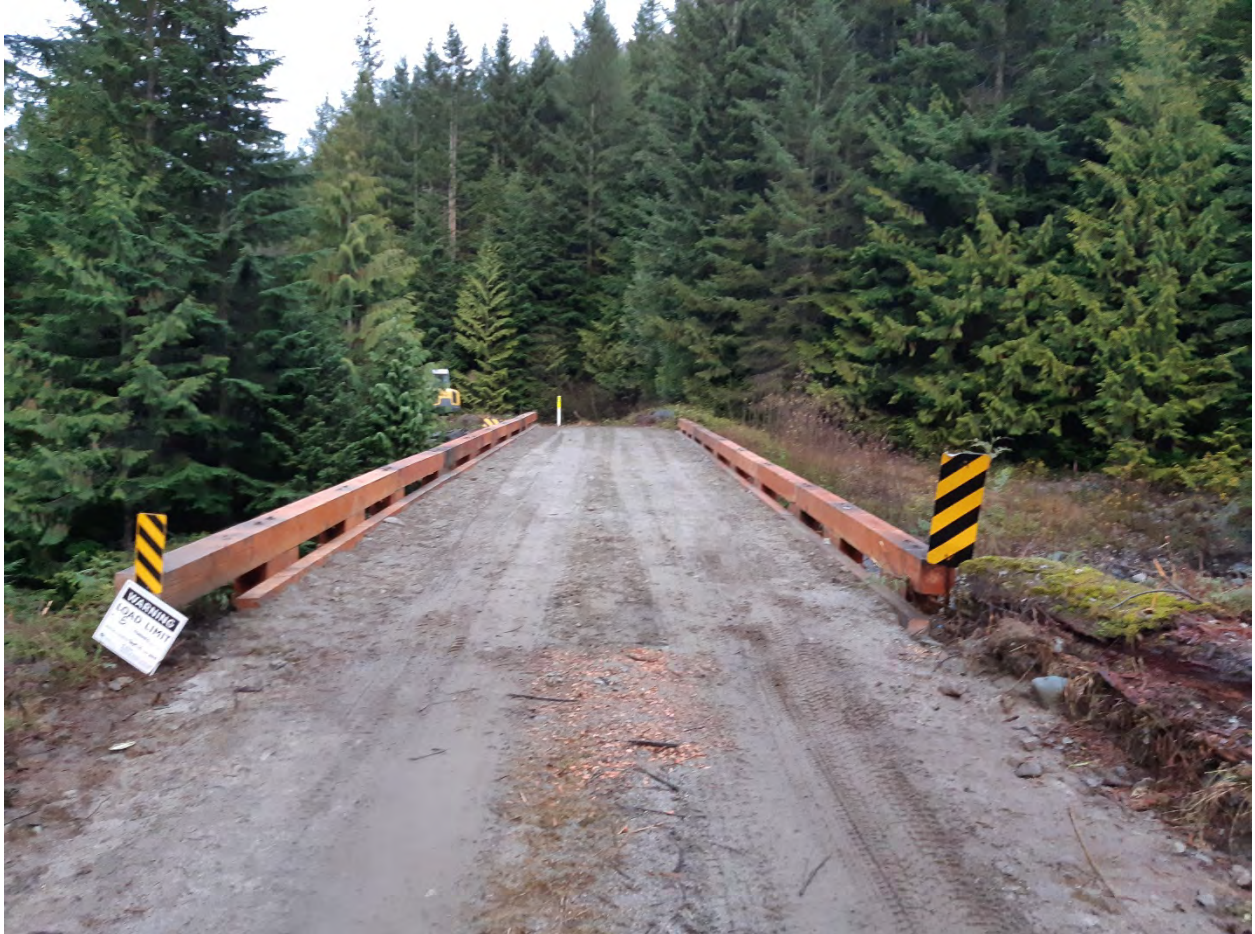
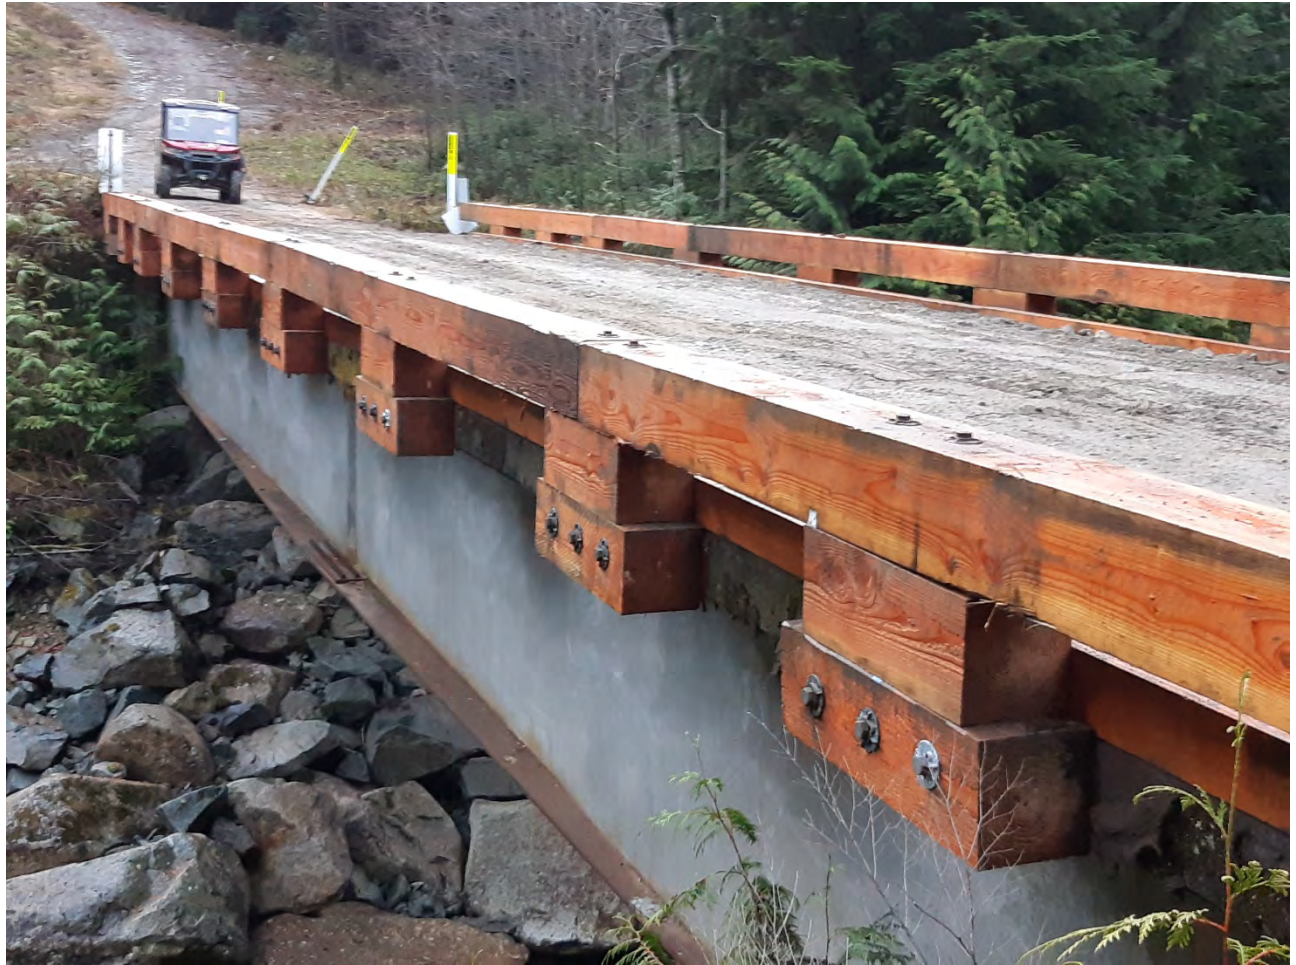
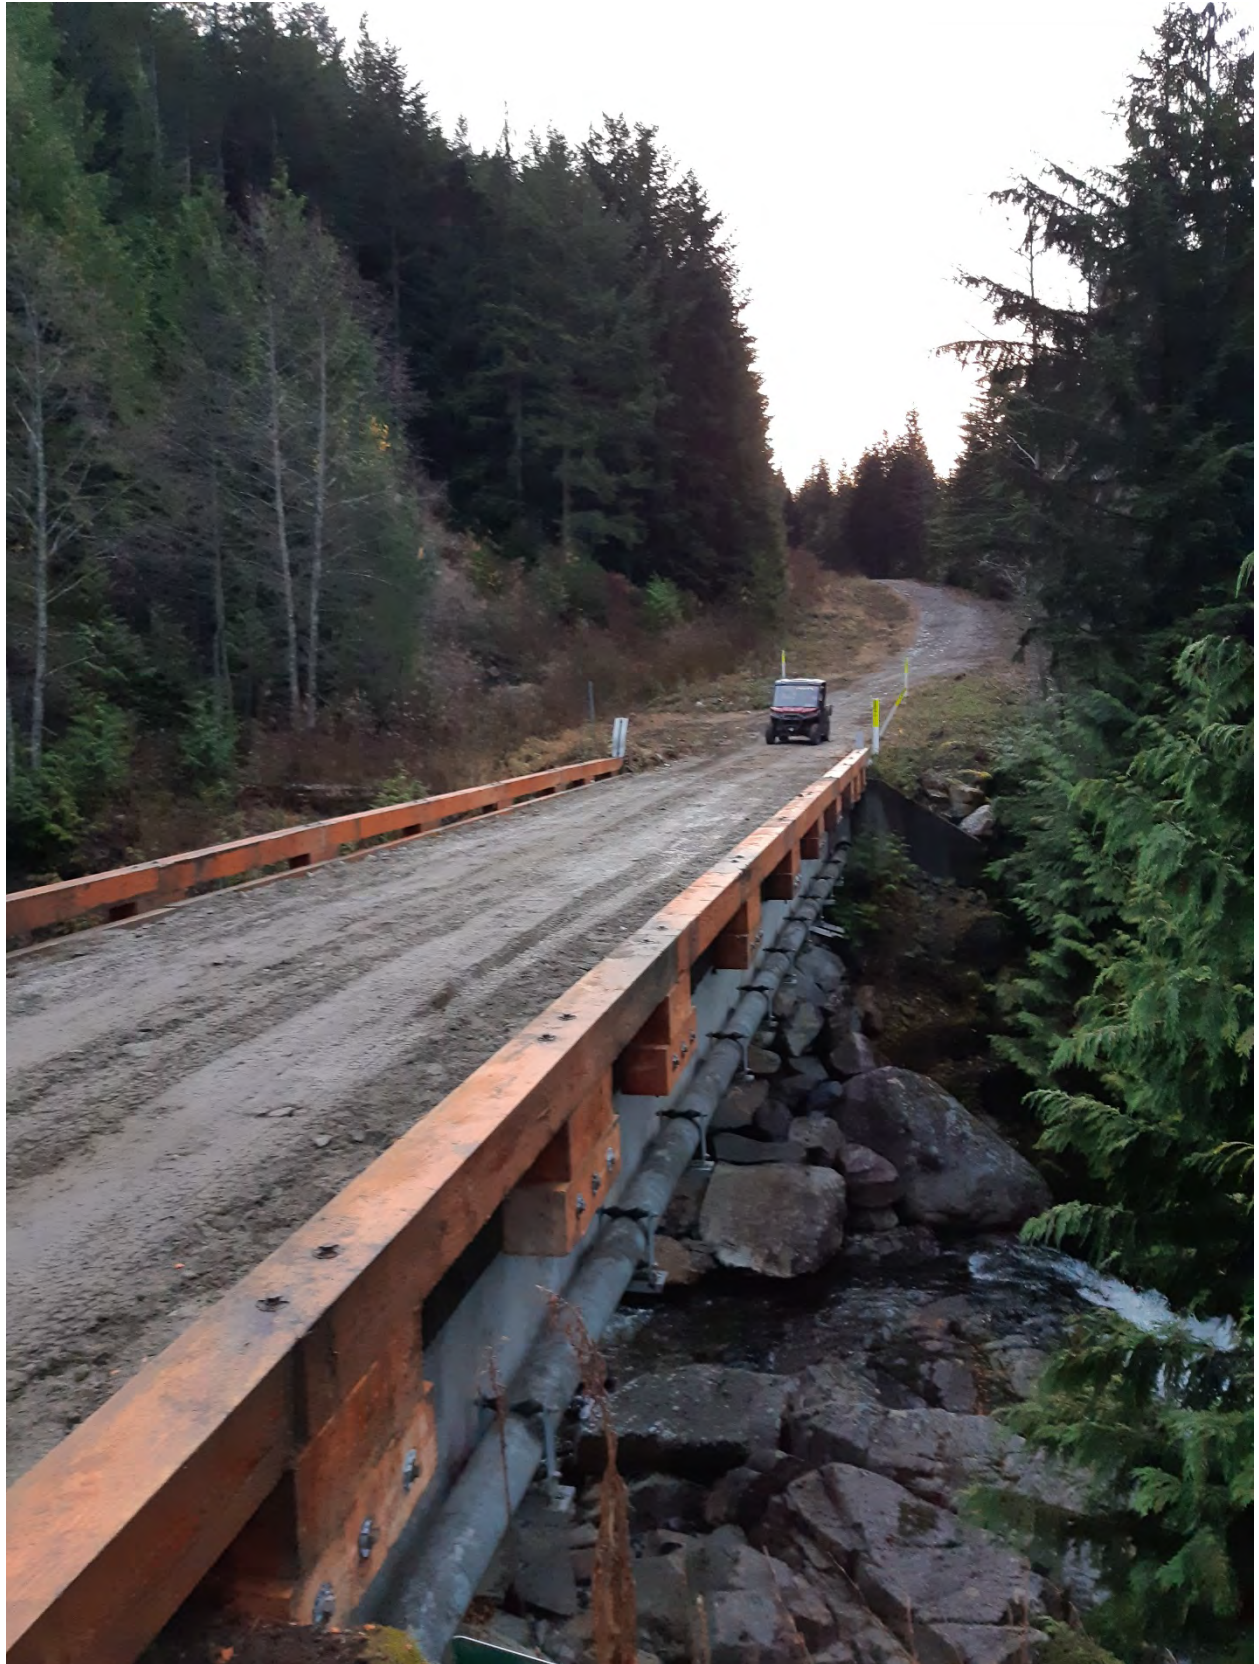
Hixon Bridge Guard Rail Replacement

Comments: Curb rails were subsequently replaced after the inspection. Load rating for bridge to be set at original load rating of L120 or 109 tonnes.
