SQ-3214

SQ\_SL2000 3.3km

2019 Inspection

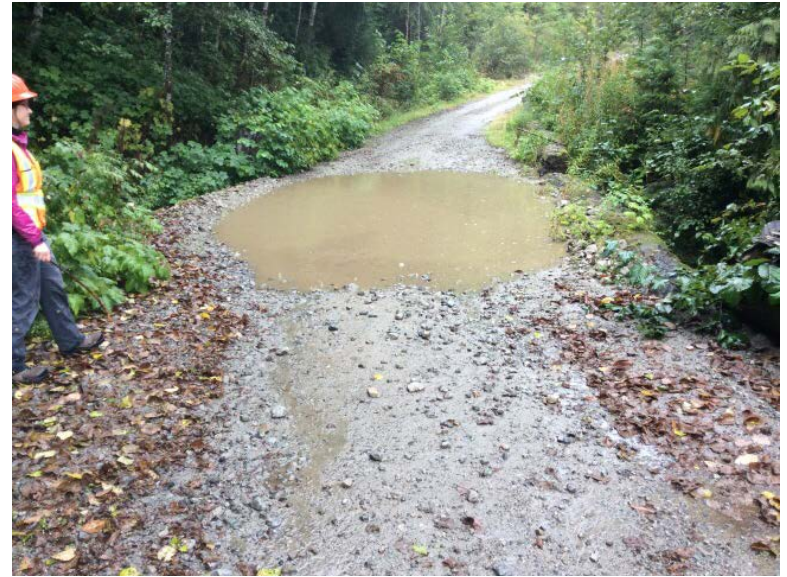
Deck

Road Surface Poor Water ponding on deck

| Curb Rail/Blocks/Posts | Poor | Curb rail is too low |

Load Rated by: MFLNRORD, Greg Dohm, PEng., January 28, 2020  
Load Rating: BCL625 or 63 tonnes  
Next Inspection: 2021  
Comments: Curb rail height to be increased prior to industrial use.
