SQ-3215

SQ\_SL2000 4.5km

2019 Inspection

| Crossing Name | Carley Creek |

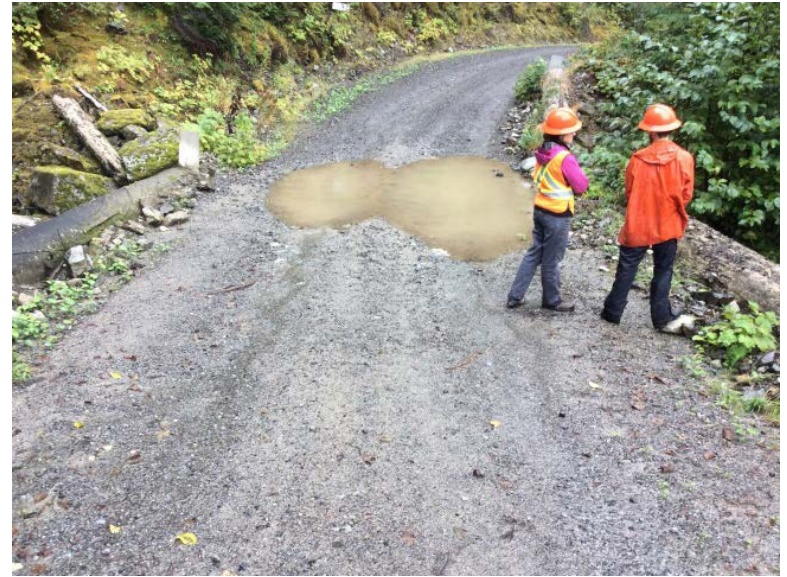
Deck

Curb Rail/Blocks/Posts      Fair      Little low on one side

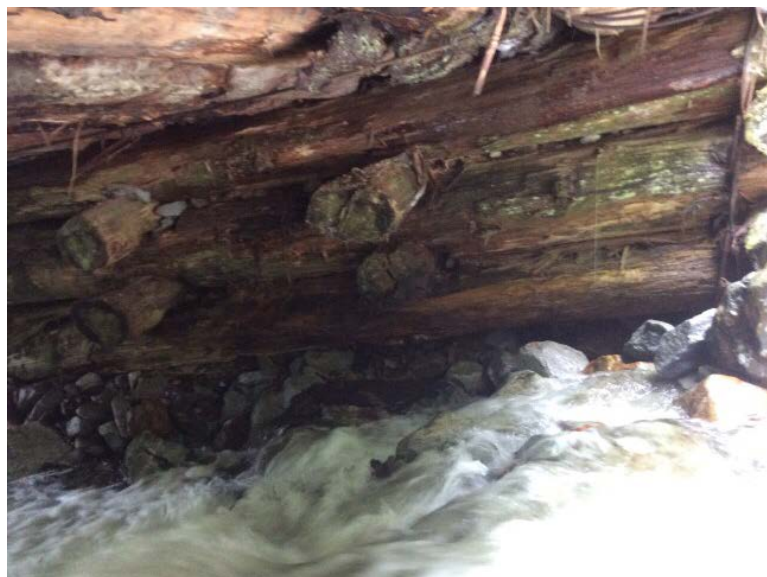
Right Bank Abutment when facing downstream

Riprap Poor No riprap and under the cribs
