SQ-3233

GREEN RIVER 01 16.5km

2019 Inspection

| Crossing Name | Ure Creek |

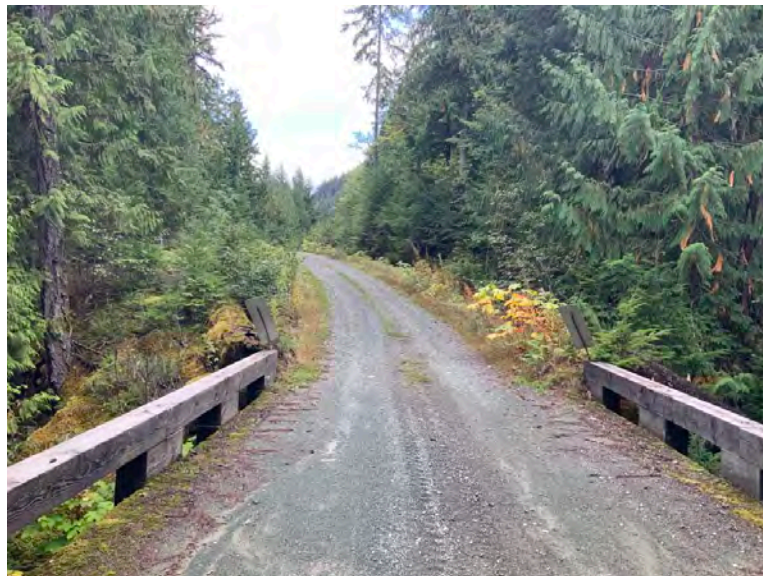
Approach from Right Bank when facing downstream

Fender Condition Fair Rocks on left side. Old logs on right side. Replace logs at next industrial use.

| Item | Priority | Repair Description |
|---|---|---|
| 1 | | Approach logs right side to be replaced at next industrial use. |

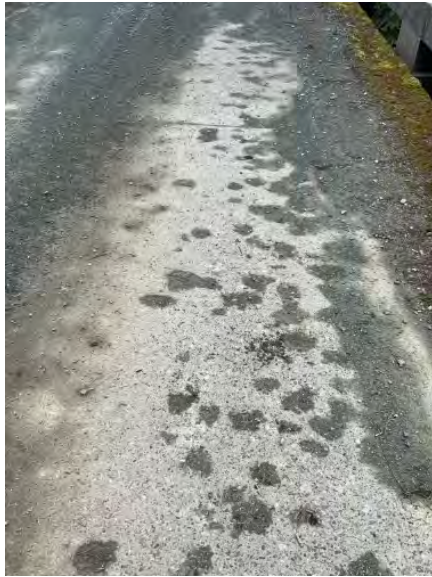
Concrete Deck      Fair      Growler damage from track vehicles on surface.

Growser damage to deck surface

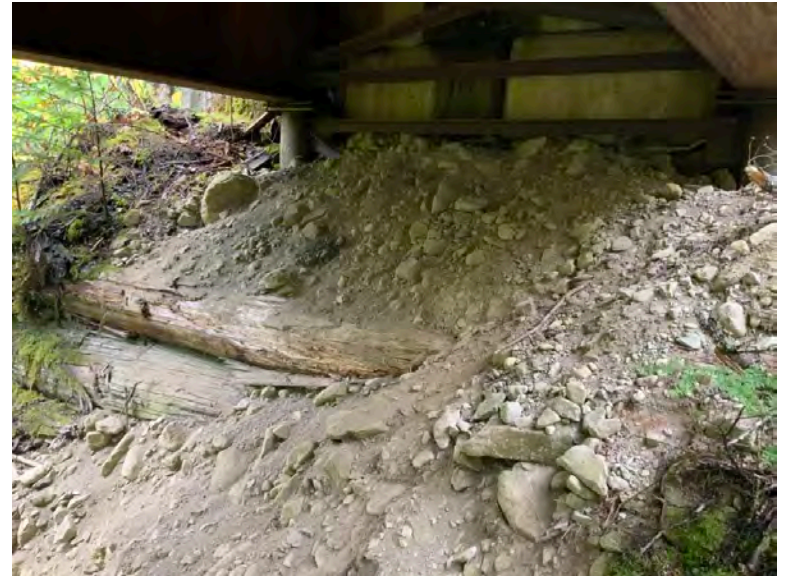
Right Bank Abutment when facing downstream

Log/Timber Cribs Fair Right side only. Don't think it supports the footings based n angle of cross bracing. Crib 2 log cw is still okay.
