SQ-3241

BREW CREEK FSR 2.2km

2019 Inspection

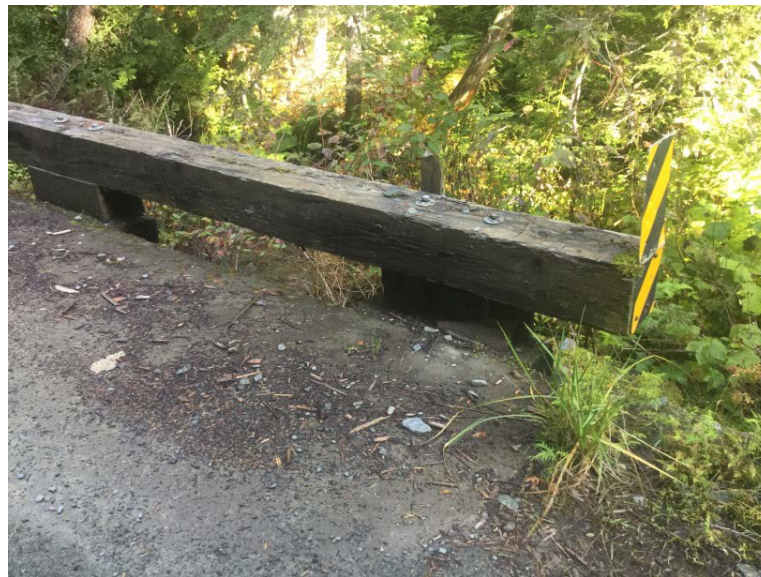
Guard Rail

Curb Rail/Blocks/Posts      Poor      Rotten.

| 2 | High | Replace guardrails |

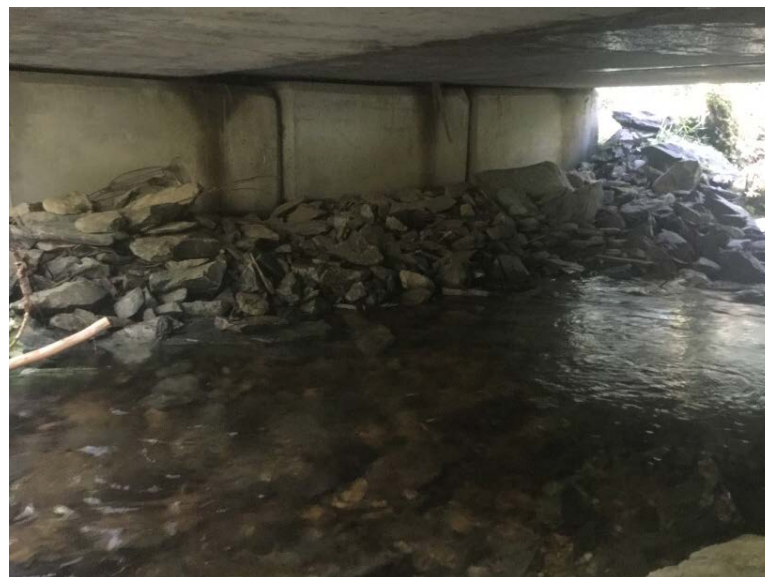
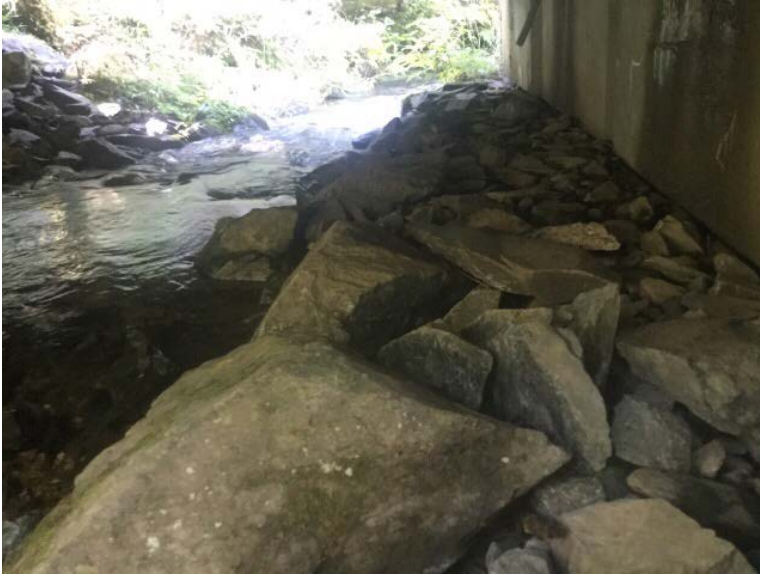
Left Bank Abutment when facing downstream

Concrete Fair Lock blocks upstream left side settled slightly. Monitor.

| Item | Monitor Description | Frequency |
|---|---|---|
| 1 | Monitor left abutment | Routine Inspection |

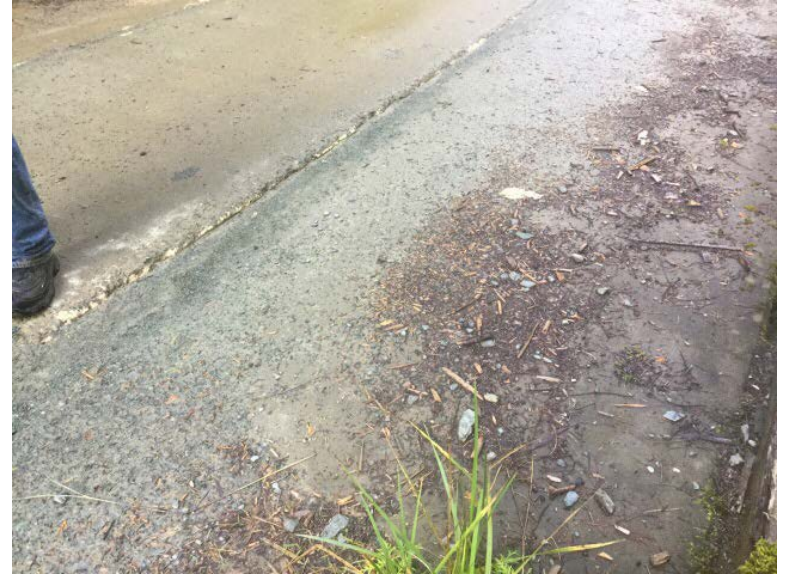
Right abutment lock blocks and upstream slab on upstream side settled slightly (approx 1"). Likely during installation. Monitor.

Upstream slab settled by approx 1" on upstream. Monitor.
