SQ-3249

SL1100 0.2km

2019 Inspection

| Structure Class | Temporary Bridge |

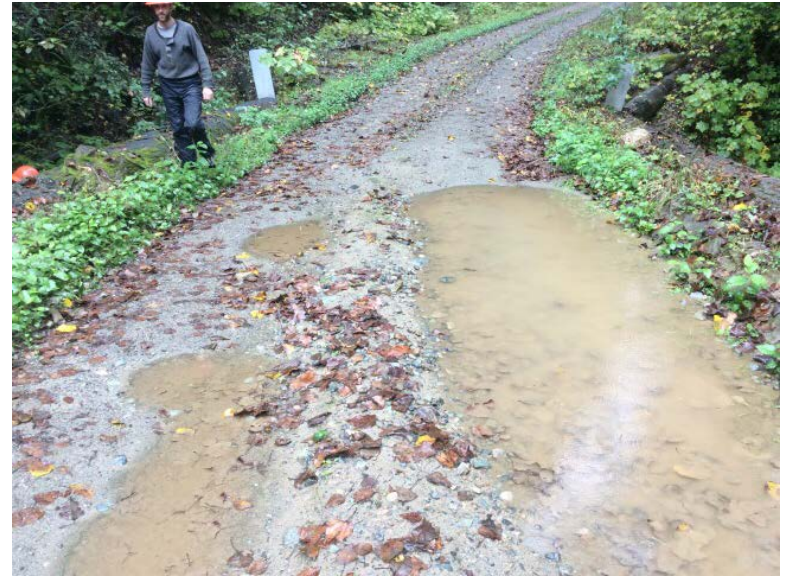
Deck

Curb Rail/Blocks/Posts      Poor      Log Curb rails low

Log Curbs    Poor    Too low

Load Rated by: MFLNRORD, Greg Dohm, PEng., January 28, 2020  
Load Rating: BCL625 or 63 tonnes  
Next Inspection: 2021  
Comments: raise curb rails to min. 250mm height prior to industrial use
