SQ-3251

IN-SHUCK-CH FSR 54.1km

2019 Inspection

| Structure Class | Major Culvert |

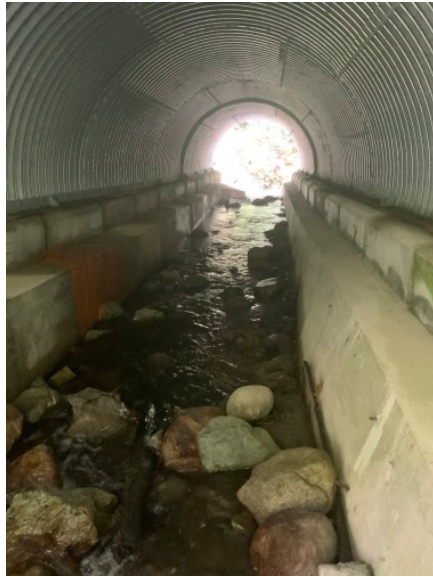
Outlet Good

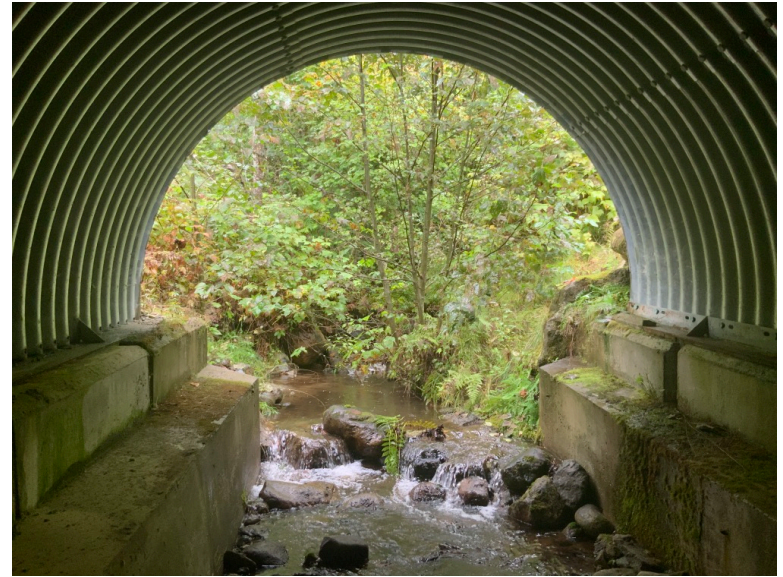
Inlet Good
