SQ-3018  
SQ-3018

RUTHERFORD 01 15.7km

2020 Inspection

| Crossing Name | Tributary to Rutherford Creek |

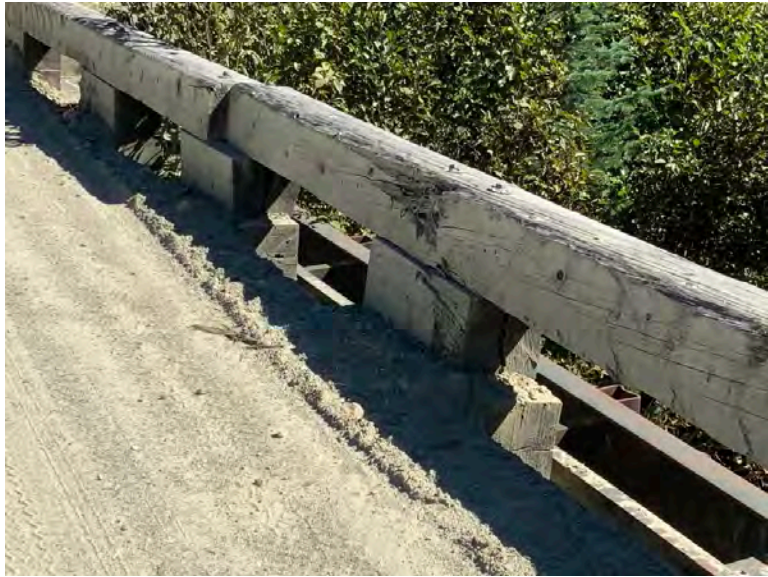
Guard Rail

Curb Rail/Blocks/Posts Poor Rotten and need to be replaced

Overall Deck Condition Poor Due to rotten rails.

Load Rated by: MFLNRORD, Greg Dohm, PEng., Jan. 4, 2021  
Load Rating: BCL625 or 63 tonnes  
Next Inspection: 2022  
Comments: Replace both side guardrails and all components prior to next industrial use

| Repair Item | Repair Description |
|---|---|
| 1 Structure. Full Curb Replacement. .<br>Priority:High | Replace both side guardrails and all components prior to next industrial use |

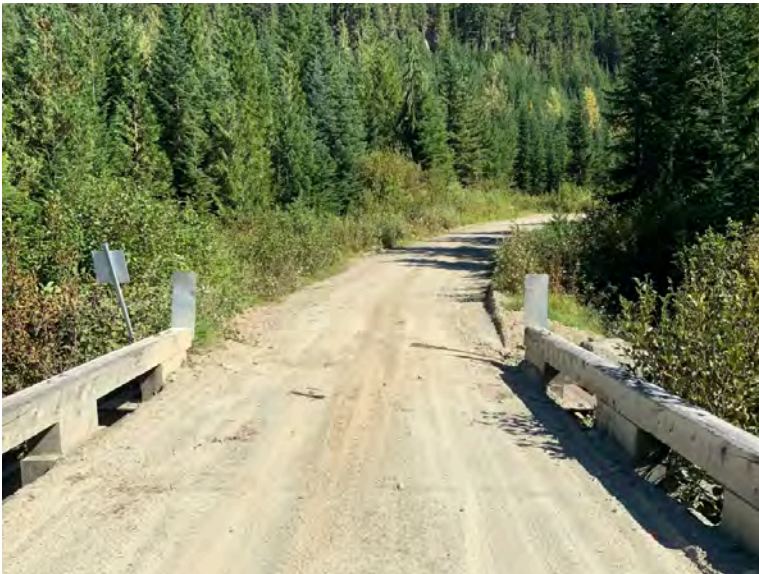
Approach from Left Bank when facing downstream

Alignment Poor

Sharp corner

Fender Condition Poor

Missing and should be added on all corners

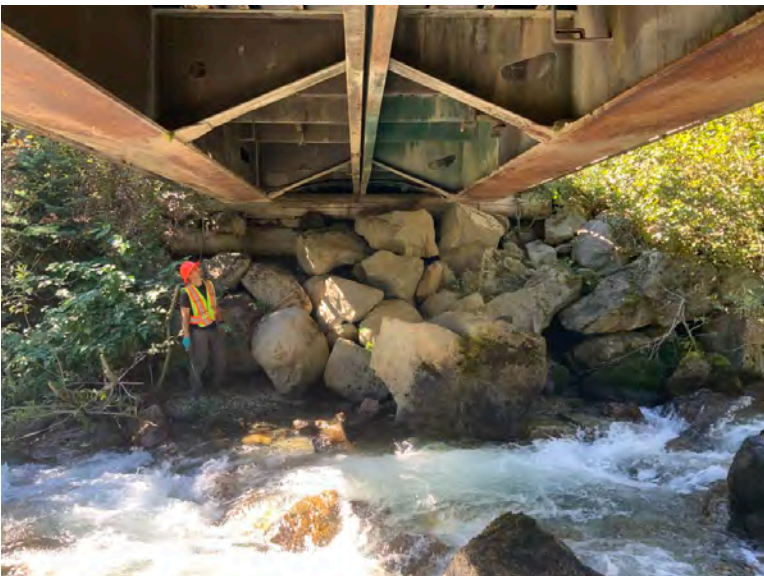
Right Bank Abutment when facing downstream

Log/Timber Cribs Fair

Tie Backs Fair

Caps or Sills Fair
