SQ-3019  
SQ-3019

HAYLMORE CREEK MAIN 1.8km

2020 Inspection

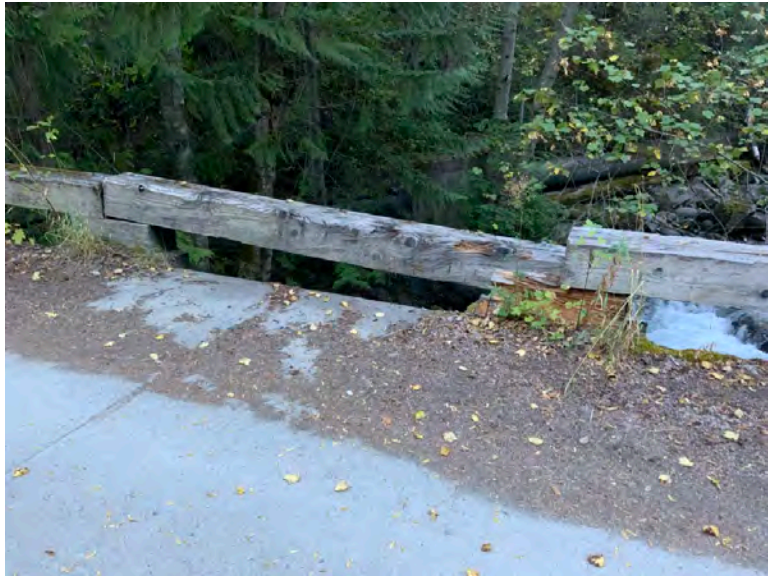
Guard Rail

| Curb Rail/Blocks/Posts | Poor | Rotten side blocks, risers and guardrails |

Load Rated by: MFLNRORD, Greg Dohm, PEng., Jan. 4, 2021  
Load Rating: L60 or 54 tonnes  
Next Inspection: 2022  
Comments: Replace guard rails before next industrial use or consider closing bridge.

| Repair Item | Repair Description |
|---|---|
| 1 Structure. Full Curb Replacement. . Priority:High | Replace all guardrail components. Consider downrating or closing bridge. |

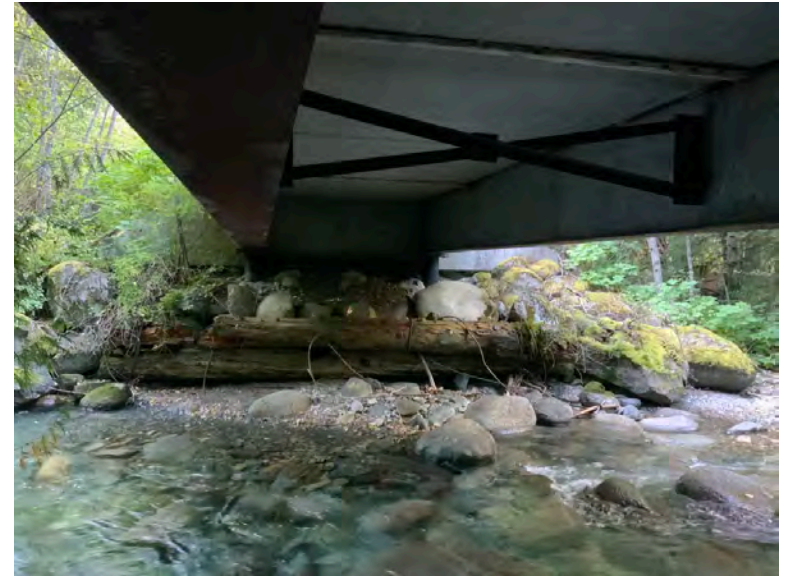
Left Bank Abutment when facing downstream

Log/Timber Cribs Poor

Rotting and collapsing

Riprap Poor

Armouring non existant on both sides

| Repair Item | Repair Description |
|---|---|
| 2 Channel. Riprap channel slopes. m³. Priority:High | Riprap below bridge both sides. Will need I stream work and small excavator to place riprap. Remove old crib logs as well. |
