SQ-3027  
SQ-3027

BIRKENHEAD MAIN 15.7km

2020 Inspection

| Crossing Name | Cerulean Creek |

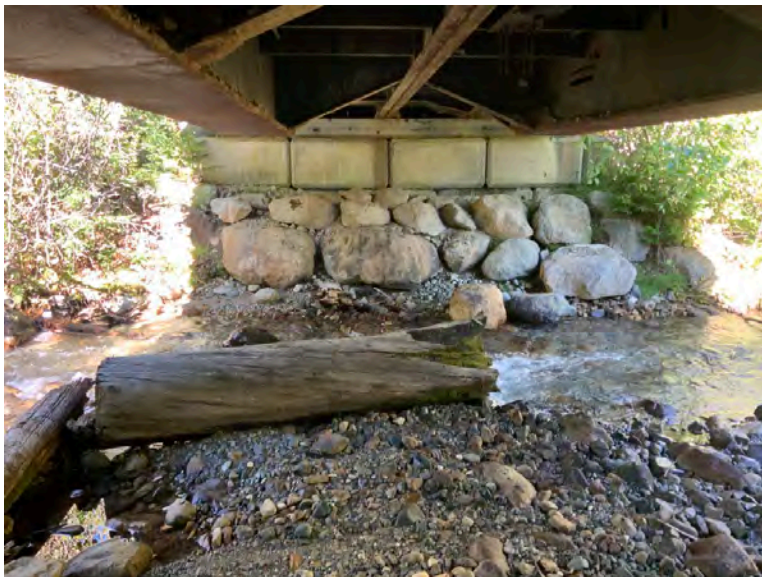
Left Bank Abutment when facing downstream

Concrete Good Lock blocks both sides at least 2 high.

Caps or Sills Fair 12x12 timbers
