SQ-3048  
SQ-3048

LILLOOET RIVER 01 34.5km

2020 Inspection

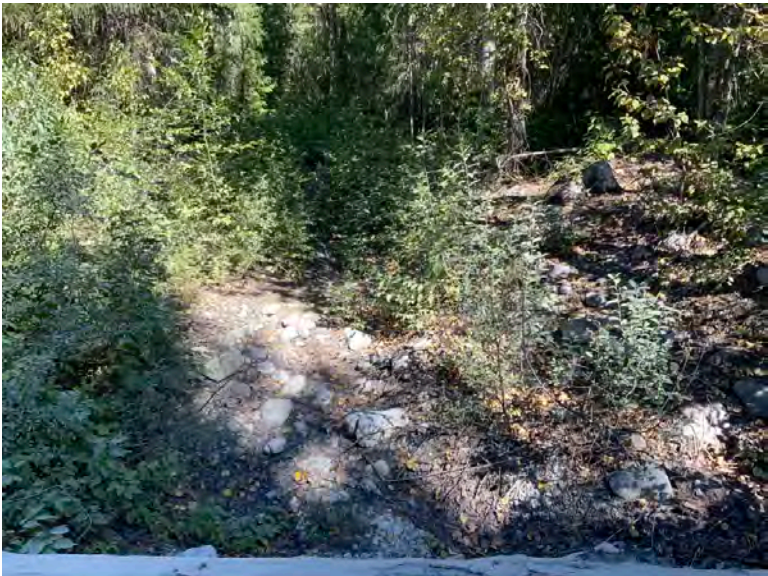
Upstream from Crossing

Load Rated by: MFLNRORD, Greg Dohm, PEng., Jan. 5, 2021  
Load Rating: BCL625 or 63 tonnes  
Next Inspection: 2022  
Comments: Remove structure and fill in as upstream creek found a new channel.

| Repair Item | Repair Description |
|---|---|
| 1 Structure. Clean-out<br>Culvert. # of panels.<br>Priority:High | Remove structure as creek no longer flows here. |
