SQ-3059  
SQ-3059

IN-SHUCK-CH FSR 10.7km

2020 Inspection

| Crossing Name | Twin Two Creek |

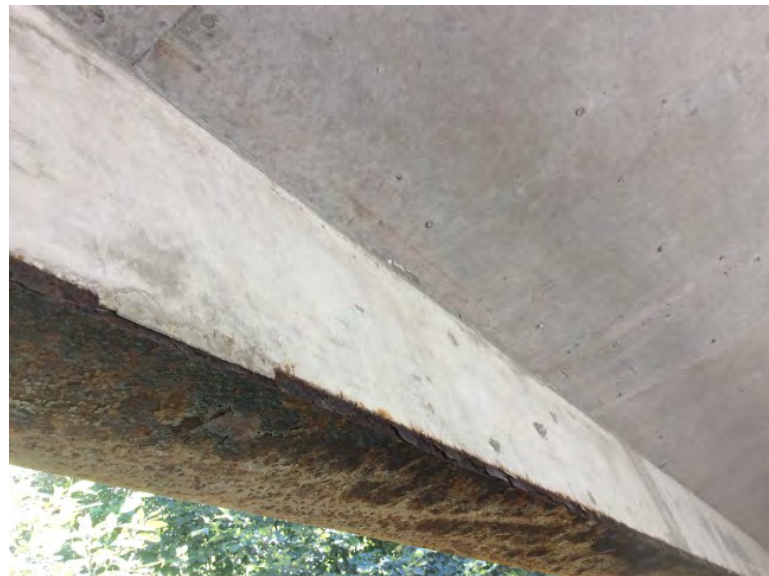
Superstructure

Corrosion Protection Fair Surface corrosion on bottom steel flange

Girders Fair Minor corrosion on bottom flange
