Sq-3076  
Sq-3076

Soo 8.2km

2020 Inspection

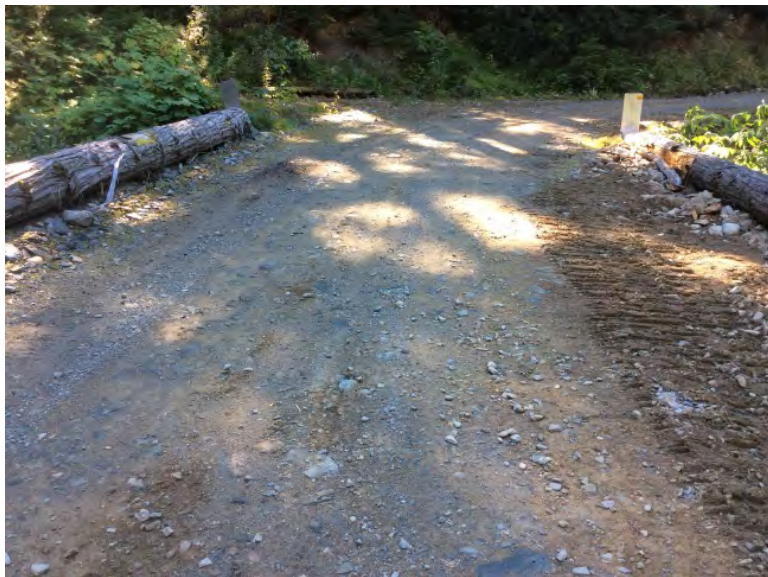
Overall Deck Condition Fair

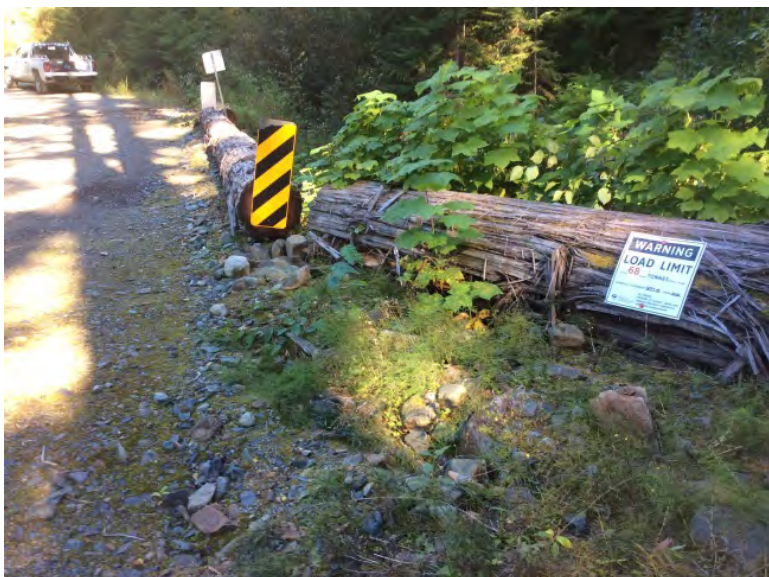
Load Rating Sign

Posted Load Rating 68 Changed from 20 to 68 tonnes
