SQ-3080  
SQ-3080

ROGERS 01 7.2km

2020 Inspection

| Crossing Name | Rogers Creek |

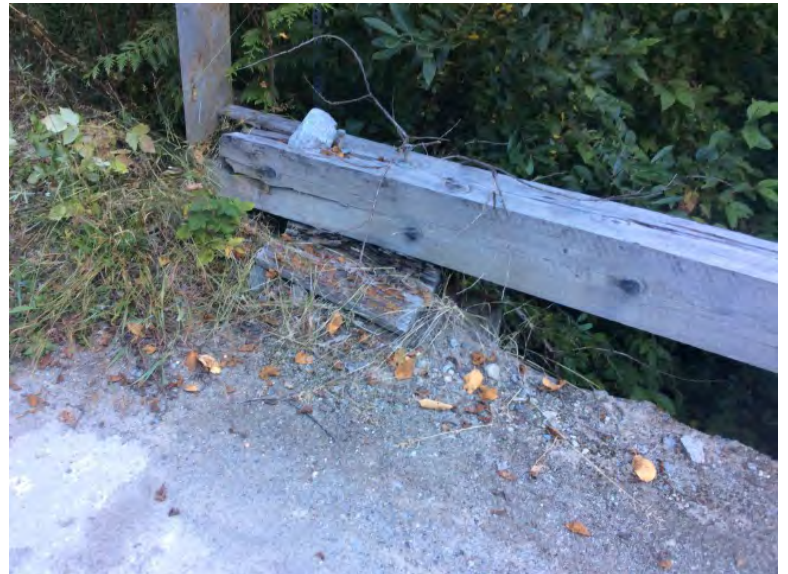
Guard Rail

Curb Rail/Blocks/Posts      Fair      Woodside curb block rotten and needs replacing. Curb rails bolts need tightening

| Repair Item | Repair Description |
|---|---|
| 1 Structure. Curb Maintenance. 1 # sites. Priority:Medium | Woodside curb block rotten and needs replacing. Curb rails bolts need tightening |
