SQ-3086  
SQ-3086

LILLOOET SOUTH 01 23.9km

2020 Inspection

| Crossing Name | Perkins Creek |

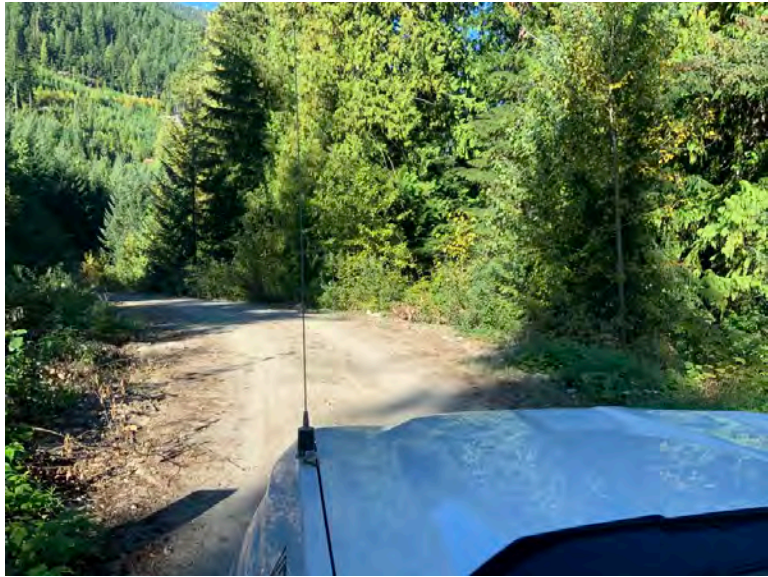
Approach from Left Bank when facing downstream

Fender Condition Poor Missing approach logs on left side

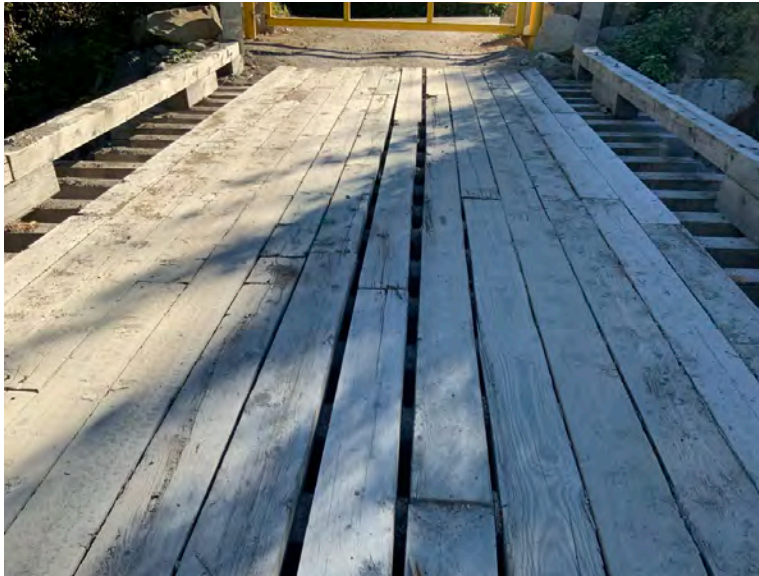
| Ties | Fair | Few are rotten. 7x10 on 500 c/c |
| Curb Rail/Blocks/Posts | Fair | Starting to get loose |
| Overall Deck Condition | Fair | |

| Repair Item | Repair Description |
|---|---|
| 1 Structure. Major redecking (crossties or laminated deck). m. Priority:Medium | Will need a full deck replacement in a few years likely |

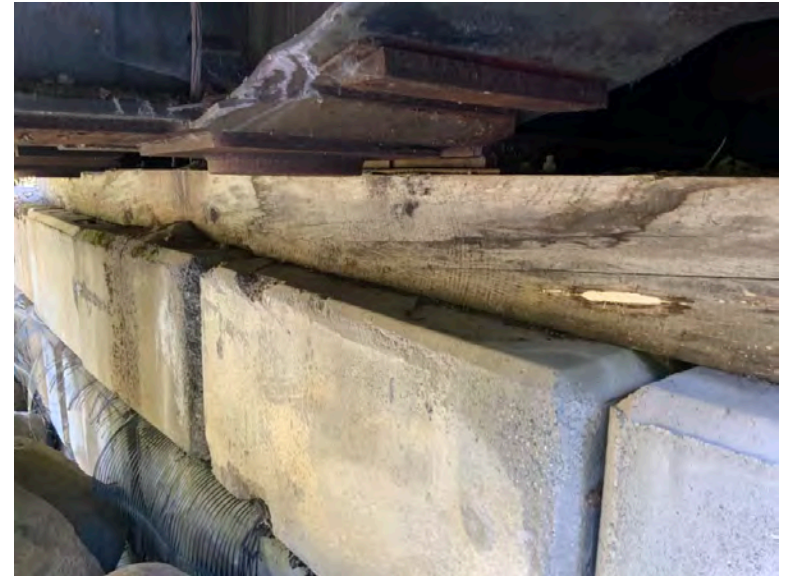
Sill right side

Caps or Sills Poor Rotting

| Item | Monitor Description | Frequency |
|---|---|---|
| 1 | Monitor sills for rot. | Routine Inspection |
