SQ-3089  
SQ-3089

IN-SHUCK-CH FSR 20km

2020 Inspection

Crossing Name Dragonfly

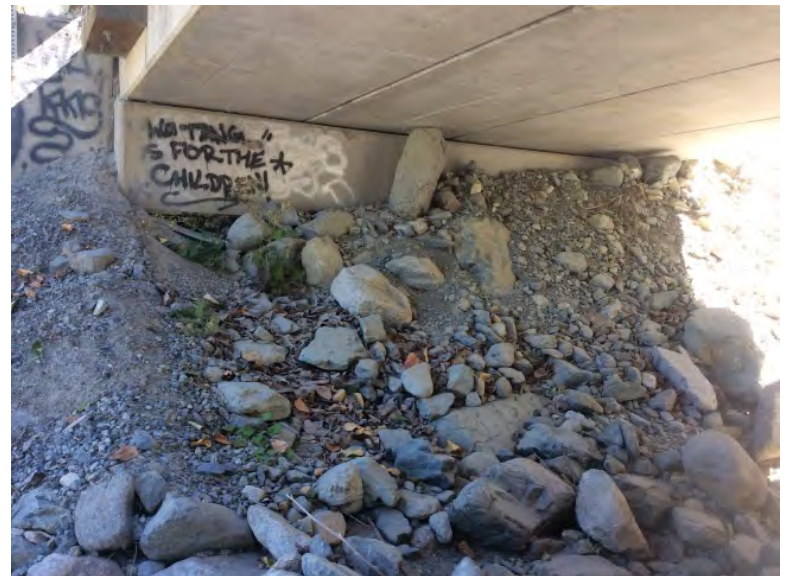
Left Bank Abutment when facing downstream

Riprap Fair Sone loss of riprap on abutments but still functioning.
