SQ-3105  
SQ-3105

FURRY CREEK 02 0km

2020 Inspection

| Crossing Name | Phylis Creek #1 |

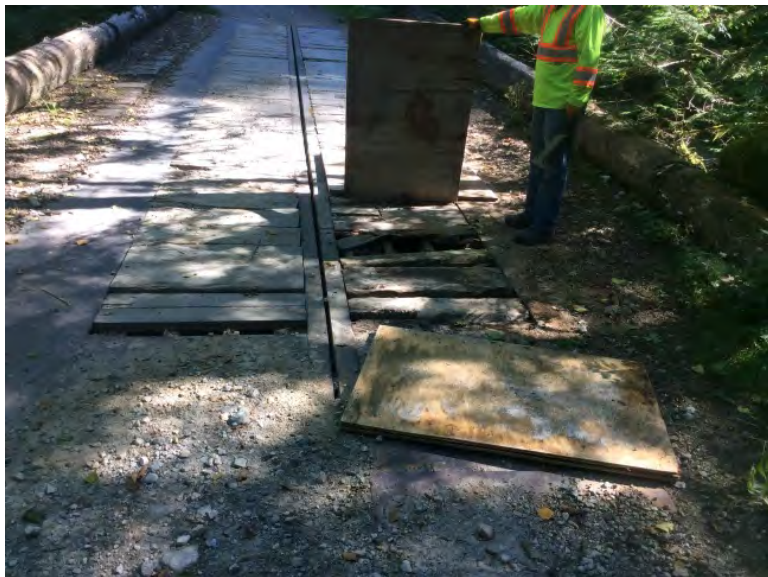
Deck has holes and is not an acceptable type of deck for railcar bridges .

Deck has holes on it and is unconventional deck. Requires timber deck replacement before next use.

Overall Deck Condition      Poor      Deck has holes and is not an acceptable type of deck for railcar bridges

Downrate to zero tonnes until deck upgraded.

| 1 | Structure. Timber deck maintenance. 1 # of signs. Priority:High | Deck has holes on it and is unconventional deck. Requires timber deck replacement before next use. |

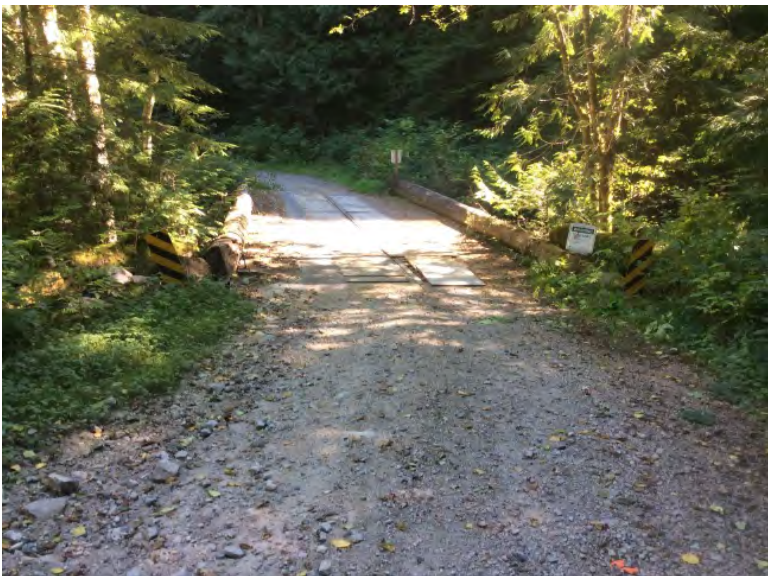
Approach from Left Bank when facing downstream

Steep approach on woods side

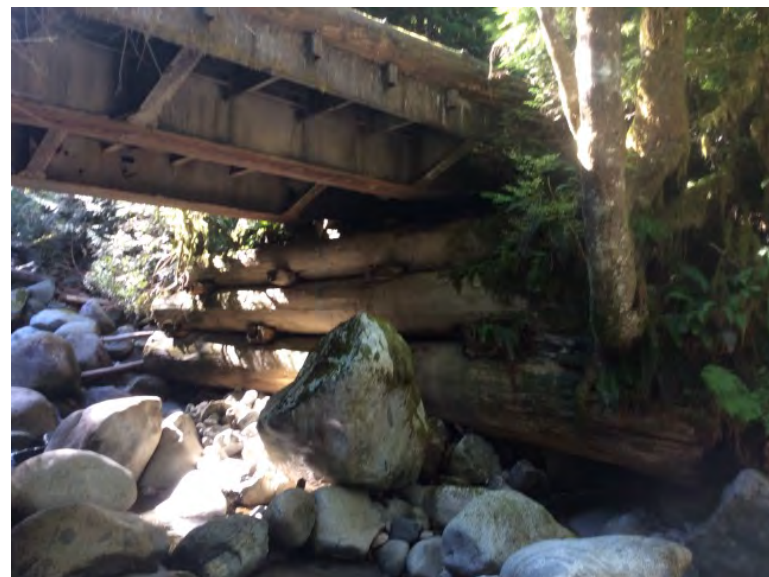
Left Bank Abutment when facing downstream

Holds back fills. Crib bottom face log heavily undermined but still appears stable at point loads on boulders.
