SQ-3117  
SQ-3117

LILLOOET WEST 01 27.8km

2020 Inspection

Crossing Name Eddy Creek

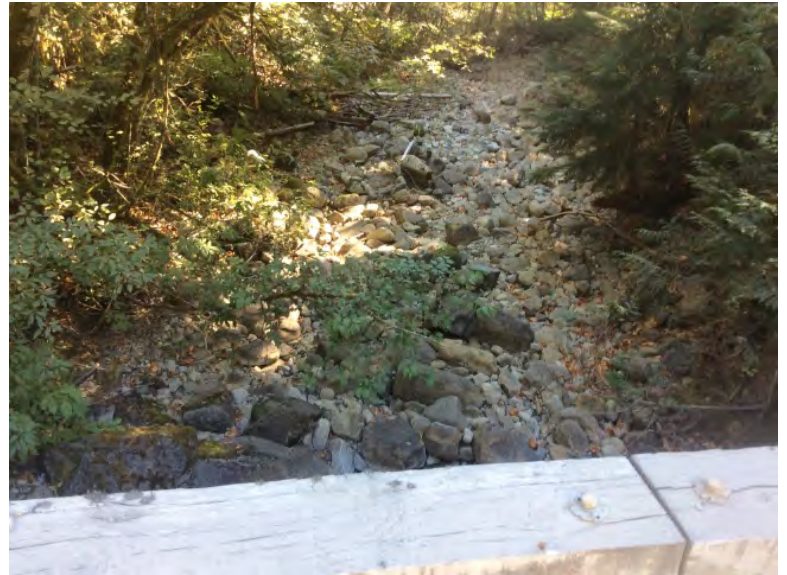
Downstream from Crossing

Downstream channel at drip line edge of bridge drops vertically 2m. Stream bed material currently retained by instream transverse log. Check depth of footings both abutments and compare to lower elevation of stream bed for potential unstable collapsed stream bed footing bear slopes. May be able to repair by dumping several loads of large clean riprap in dry stream bed to prevent collapse of upstream stream bed. Build tote road each side of bridge to place the clean grade riprap.

| Repair Item | Repair Description |
|---|---|
| 2 Channel. Add Riprap<br>(loose/dumped). 1 m³.<br>Priority:Medium | Downstream channel at drip line edge of bridge drops vertically 2m. Stream bed material currently retained by instream transverse log. Check depth of footings both abutments and compare to lower elevation of stream bed for potential unstable collapsed stream bed footing bear slopes. May be able to repair by dumping several loads of large clean riprap in dry stream bed to prevent collapse |
