SQ-3120  
SQ-3120

LILLOOET WEST 01 47km

2020 Inspection

| Crossing Name | Tuwasus Creek |

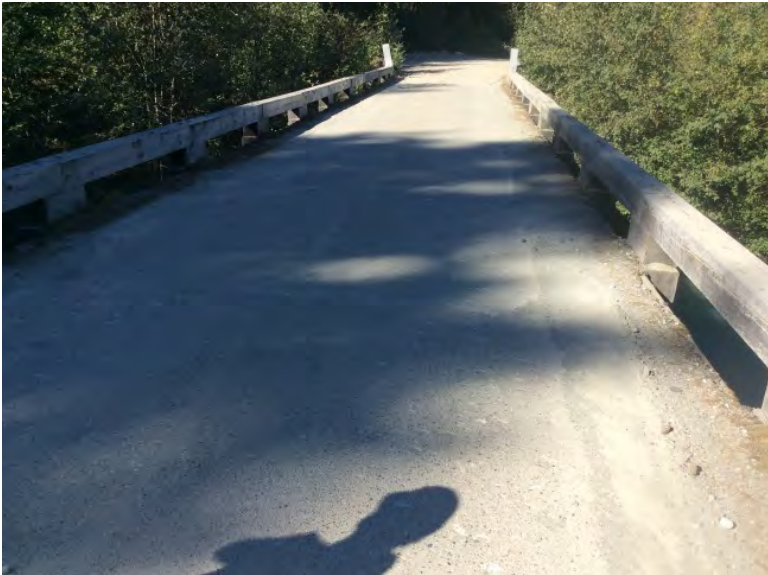
Deck

Curb Rail/Blocks/Posts      Fair      Getting old and loose. Tighten curb riser bolts.
