SQ-3121  
SQ-3121

LILLOOET WEST 01 49.7km

2020 Inspection

| Crossing Name | Flood Creek |

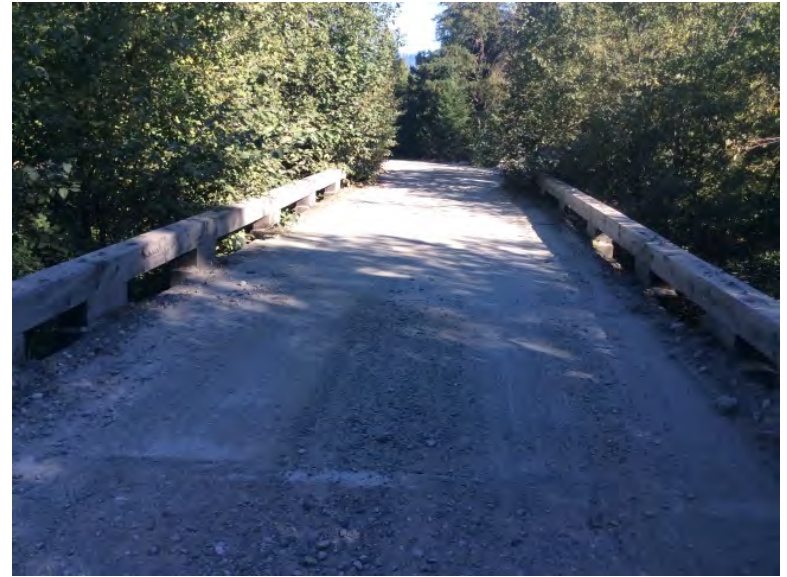
Deck

Curb Rail/Blocks/Posts Fair Curbs are loose and timbers are old. Replace asap and tighten curbs in meantime.

| Repair Item | Repair Description |
|---|---|
| 2 Structure. Curb<br>Maintenance. # sites.<br>Priority:High | Curbs are loose and timbers are old. Replace asap and tighten curbs in meantime. |
