SQ-3126  
SQ-3126

WEDGE 01 0.1km

2020 Inspection

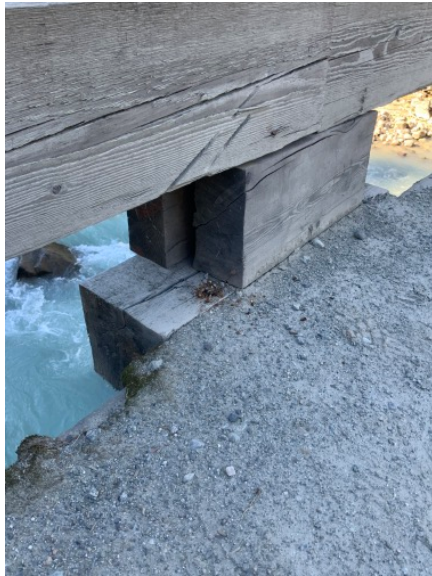
Guard Rail

| Curb Rail/Blocks/Posts | Poor | Rotten side blocks and risers |

Load Rated by: MFLNRORD, Greg Dohm, PEng., Jan. 7, 2021  
Load Rating: L60 or 54 tonnes  
Next Inspection: 2022  
Comments: replace curb rails asap and prior to industrial use or consider closing bridge.

| 1 | Structure. Full Curb Replacement. .<br>Priority:High | Side blocks and risers fully rotten. Need to replace ASAP prior to any industrial use and consider blocking access to public as there is alternate access through wedgewood subdivision. |
