SQ-3127  
SQ-3127

DAISY 01 1km

2020 Inspection

| Crossing Name | Cheakmus River |

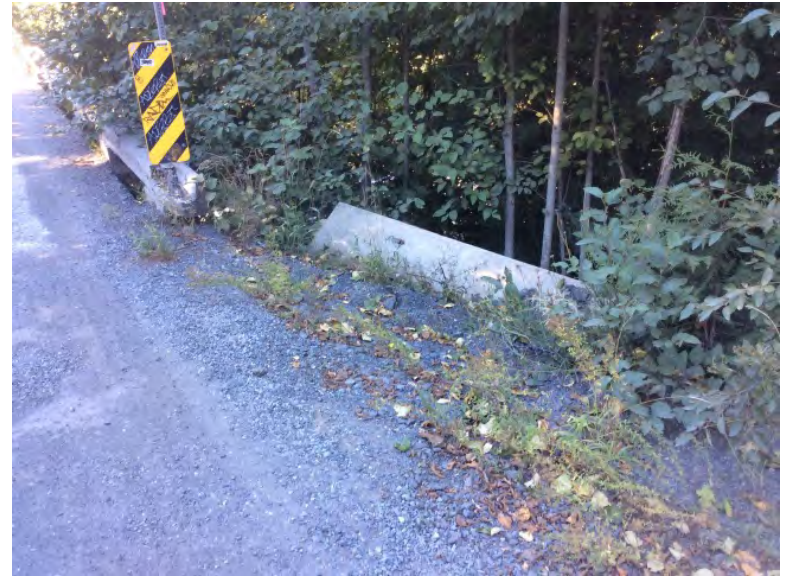
Approach Barrier

Pushed into ditch on woodside and townside

Comments: No posts approach barriers pushed into ditch to be reinstalled. Curb rails being replaced with HSS in 2021.

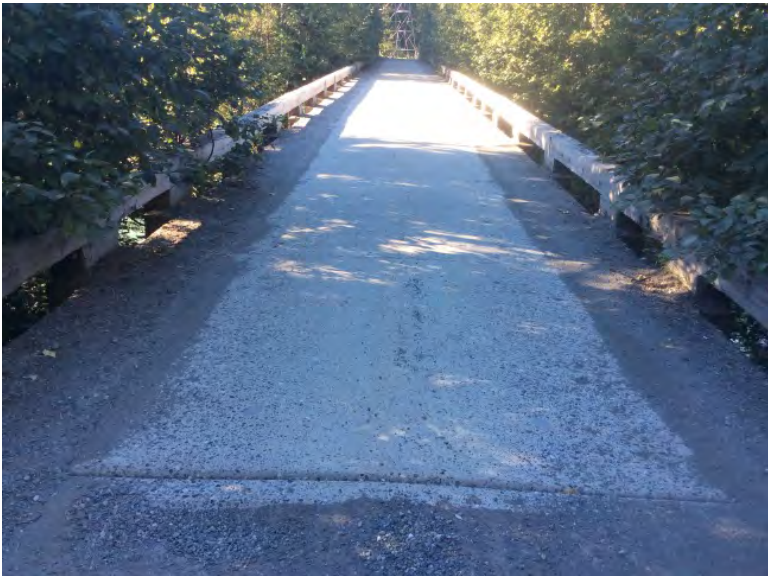
Deck

Curb Rail/Blocks/Posts Poor Curb rails need replacing ASAP for continued use. Rotting and loose and missing blocks.

| Repair Item | Repair Description |
|---|---|
| 1 Structure. Full Curb Replacement. .<br>Priority:High | Curb rails need replacing ASAP for continued use. Rotting and loose and missing blocks. |

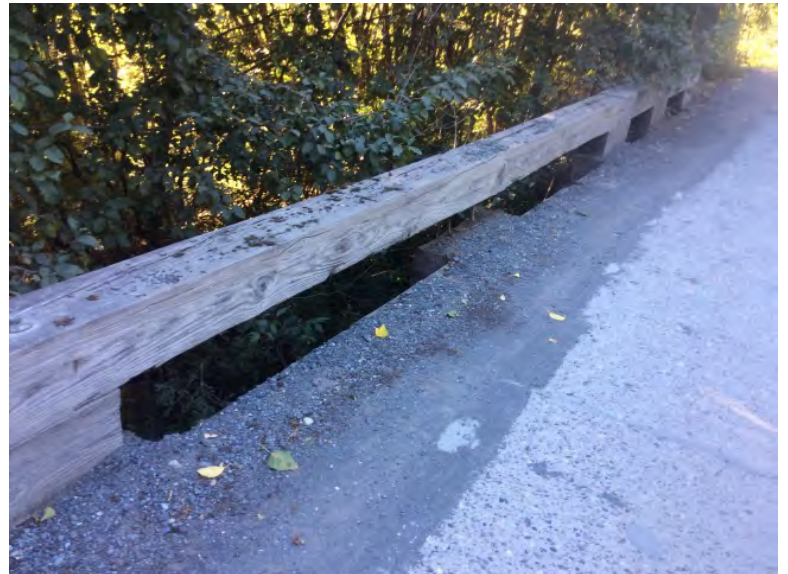
Guard Rail

Curb rails and curb blocks need replacing ASAP for continued use. Rotting and loose and missing blocks.
