SQ-3130  
SQ-3130

MAMQUAM 01 4.5km

2020 Inspection

Crossing Name Stawamus River

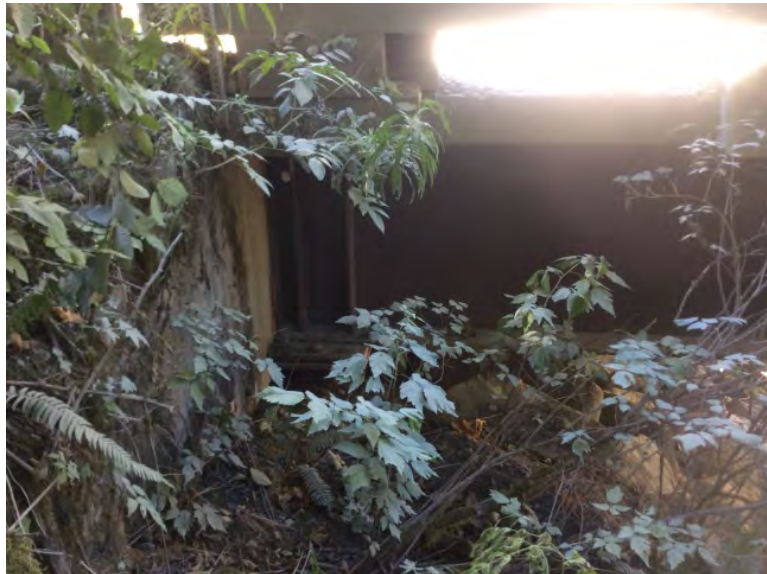
Bearings Fair Bearing look ok except for significant corrosion

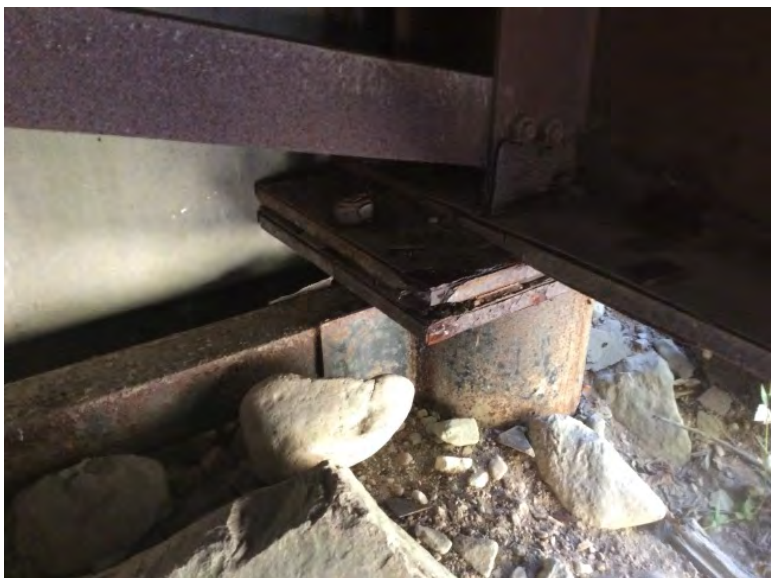
Corrosion Protection Poor Bearings corroding. Minor amount of corrosion on girders

Bearing - townside corroding bearing

Comments: Inspect annually due to corroding bearing places and girders. FLNRO to conduct close proximity inspection to determine extent of corrosion.

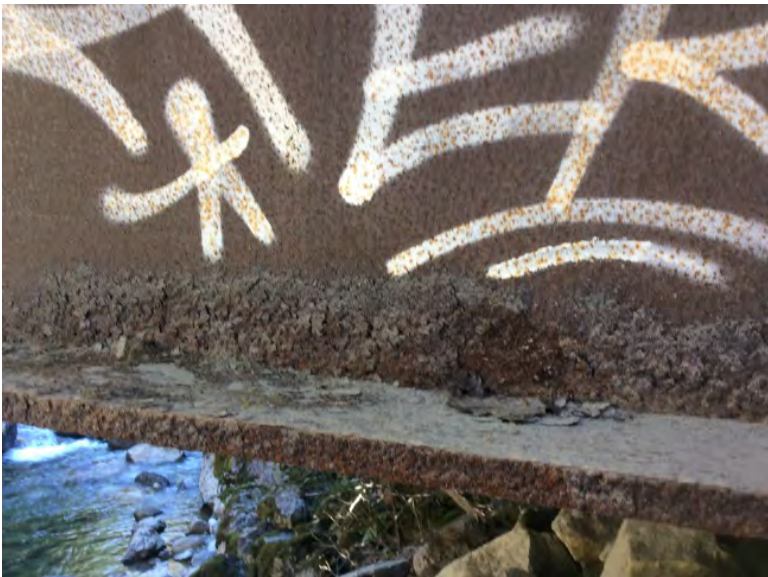
Superstructure

Girders Fair Bearing plates corroding and girder

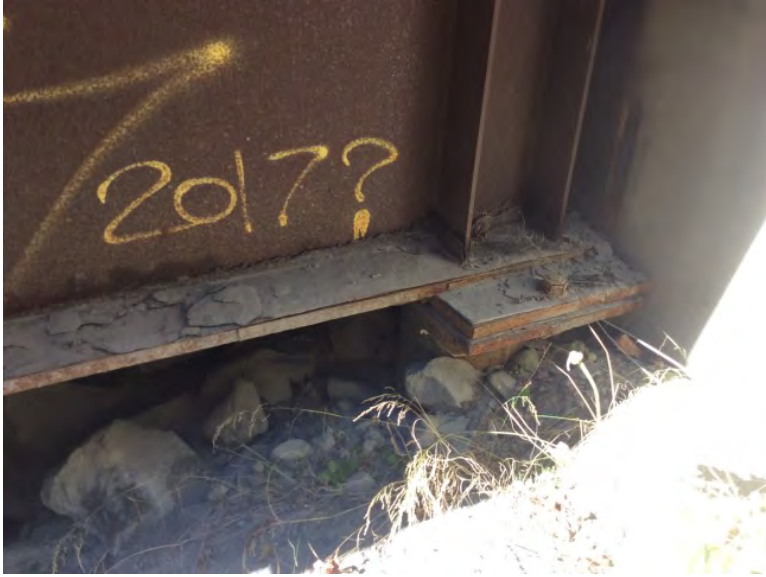
Bearing - u/s woodside corroding bearing plates
