SQ-3143  
SQ-3143

SPRUCE 01 0.1km

2020 Inspection

Crossing Name Spruce Creek

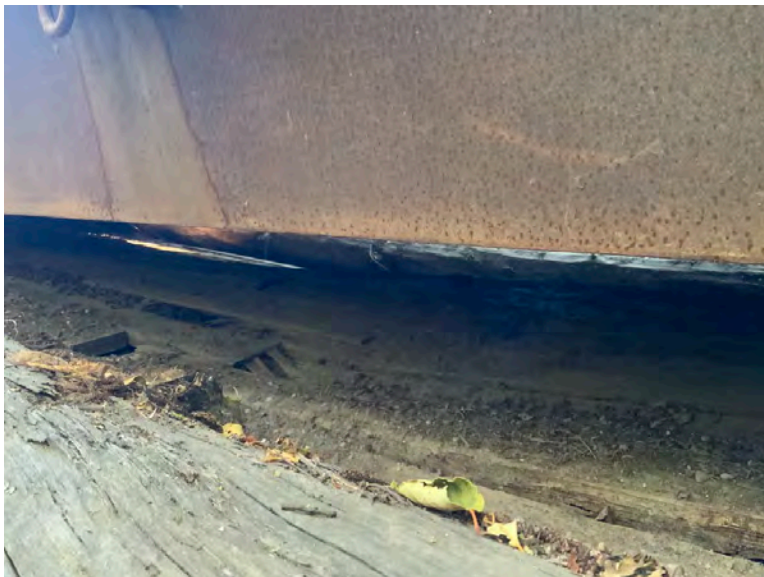
Old log bridge collapsing

| Repair Item | Repair Description |
|---|---|
| 1 Miscellaneous. Total Structure Replacement. # of items. Priority:High | Remove log bridge before it fully collapses and plugs the stream and blows out the portable with it. |

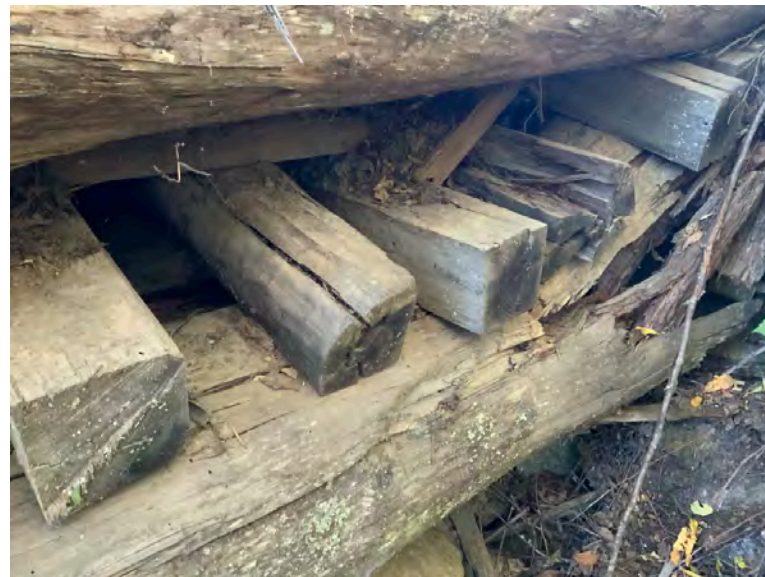
Broken stringer
