SQ-3144  
SQ-3144

## SQUAMISH RIVER 41.8km

2020 Inspection

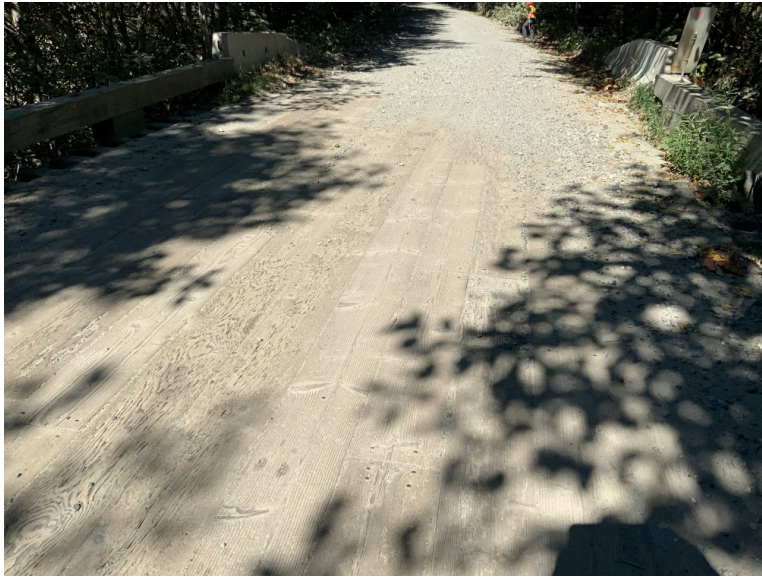
| Overall Deck Condition | Fair | |

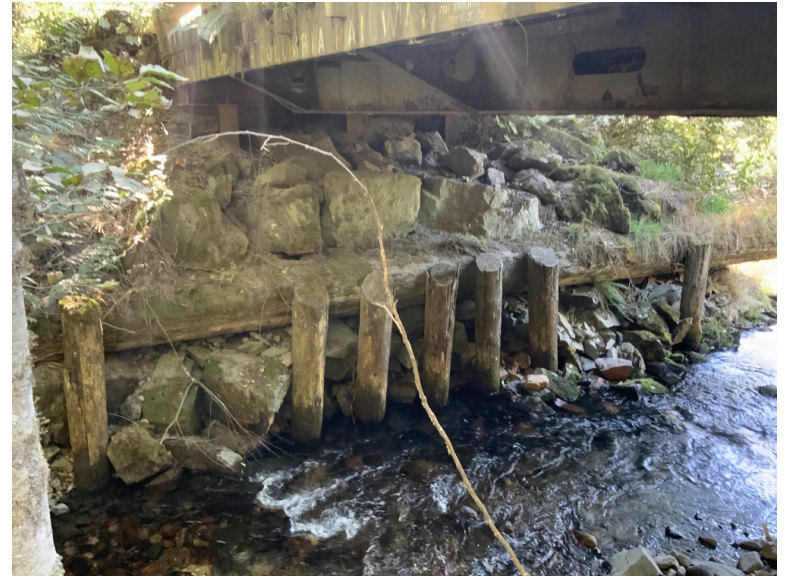
Left Bank Abutment when facing downstream

Fill Poor Riprap held by old wood piles

| Item | Monitor Description | Frequency |
|---|---|---|
| 1 | Riprap | Routine Inspection |
