SQ-3155  
SQ-3155

## SQUAMISH RIVER 53.1km

2020 Inspection

| Crossing Name | Shovel Nose Creek |

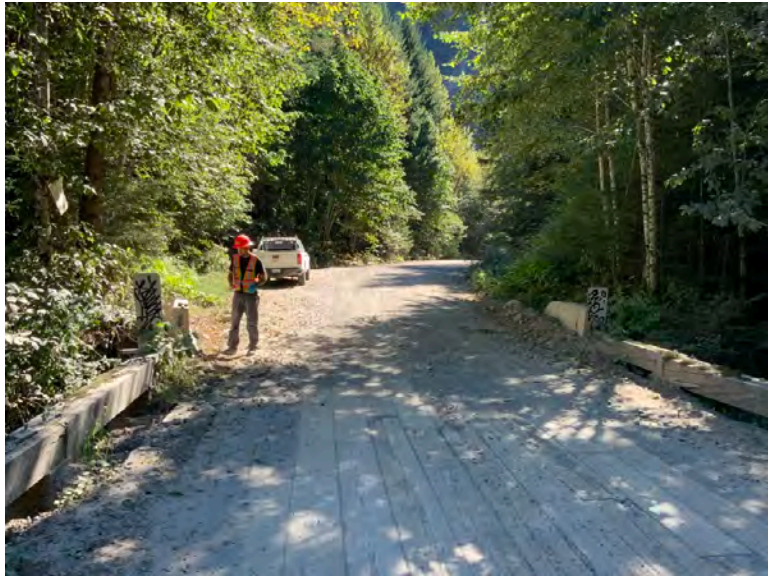
Approach from Left Bank when facing downstream

Alignment Fair

Road Surface Good

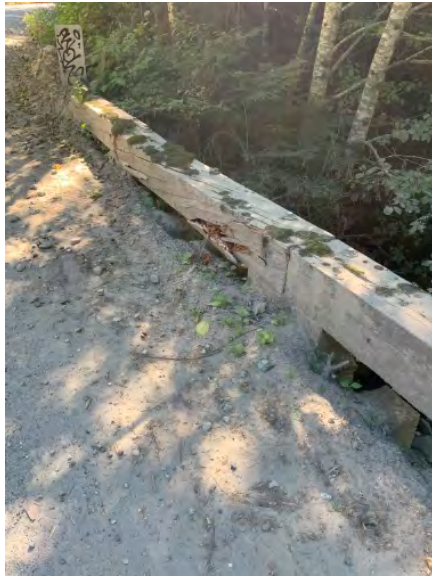
Guard Rail

Consider downrating due to rails not being replaced as per last inspections.

| Curb Rail/Blocks/Posts | Poor | Rotten and need to be replaced |
| Overall Deck Condition | Poor | Due to rails. |

Comments: Replace all rail components prior to next industrial use as they are very rotten.

| Repair Item | Repair Description |
|---|---|
| 1 Structure. . . Priority:High | Replace all rail components prior to next industrial use as they are very rotten. |

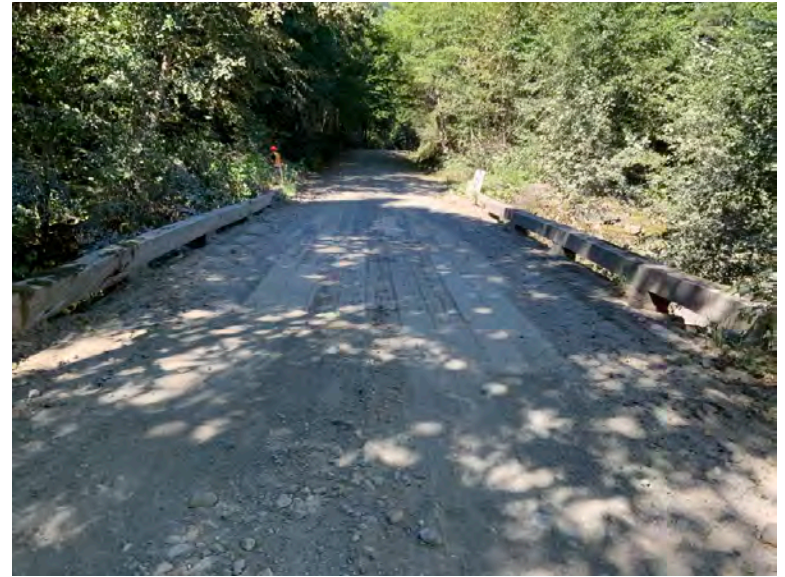
Deck

| Running Surface | Fair | |
| Running Planks | Fair | 4x12 |
| Ties | Fair | 8x8 treated |

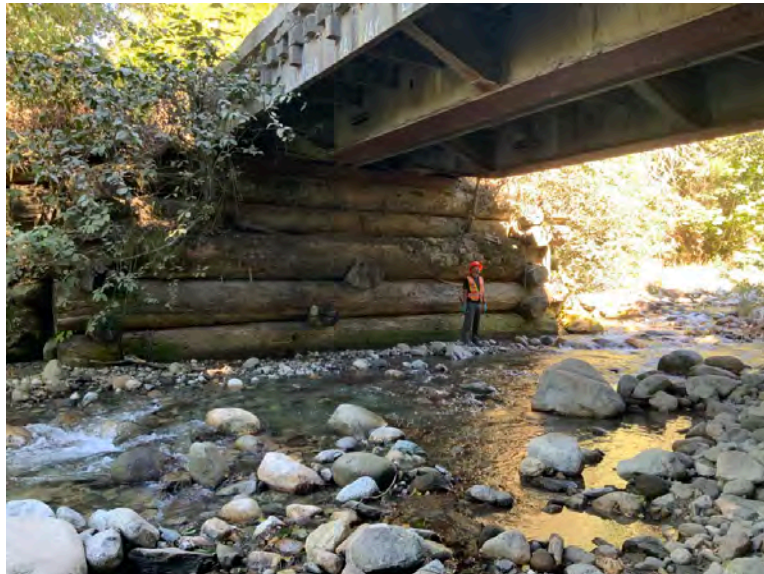
Right Bank Abutment when facing downstream

Log/Timber Cribs Fair

Tie Backs Poor Getting old

Caps or Sills Fair
