SQ-3158  
SQ-3158

## SQUAMISH RIVER 36.6km

2020 Inspection

| Crossing Name | High Falls Creek |

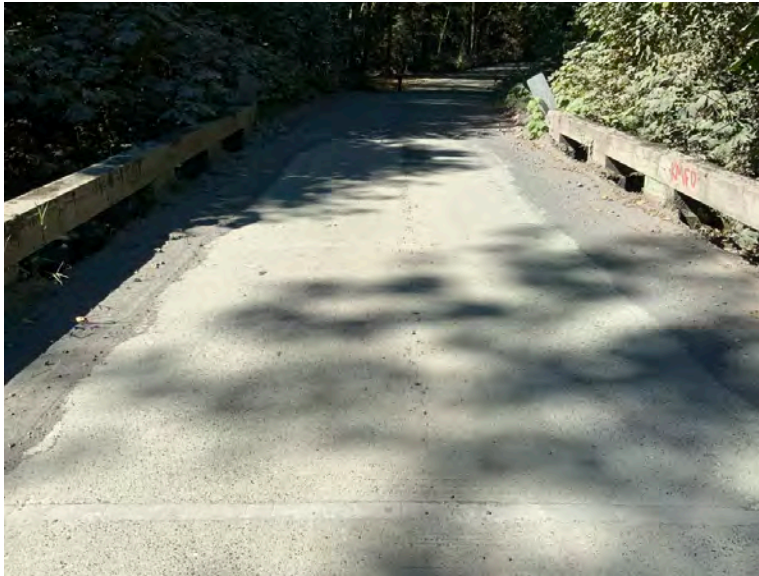
| Overall Deck Condition | Good | |

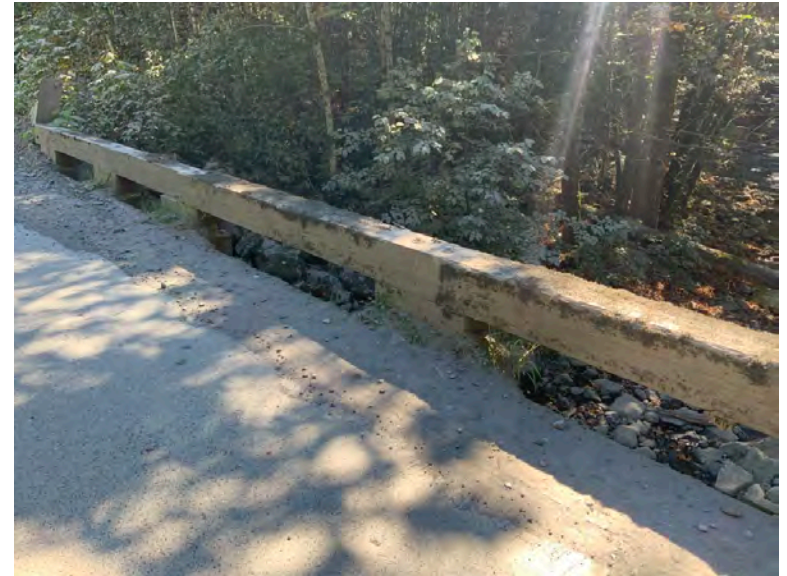
Guard Rail

Consider downrating as rails not replaced as per last inspection

| Curb Rail/Blocks/Posts | Poor | Rotten |

Load Rated by: MFLNRORD, Greg Dohm, PEng., Jan. 7, 2021  
Load Rating: L100 or 91 tonnes  
Next Inspection: 2023  
Comments: Replace rotten guardrails.

| Repair Item | Repair Description |
|---|---|
| 1 Structure. Full Curb Replacement. .<br>Priority:High | Replace rotten guardrails. |

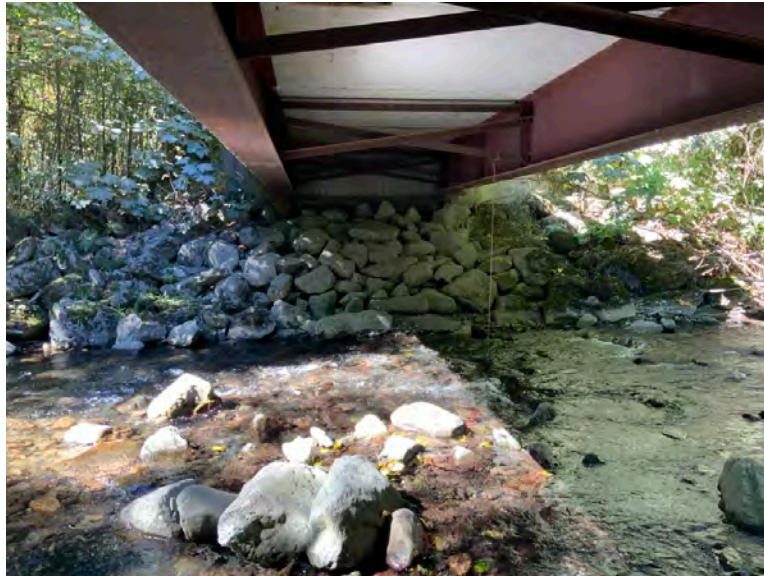
Right Bank Abutment when facing downstream

Piles or Posts Fair
