## SQUAMISH RIVER 25.1km

2020 Inspection

| Crossing Name | Terminal Creek |
| Structure Class | Major Culvert |

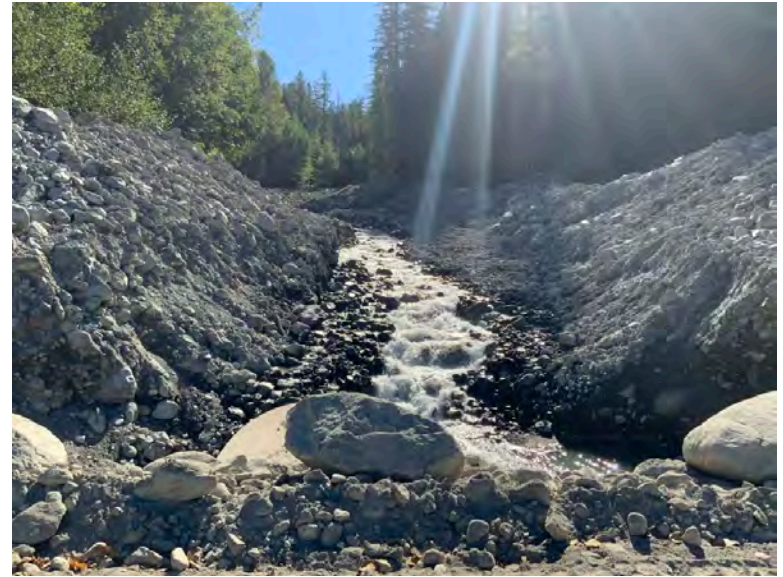
Upstream from Crossing

| Comments | Debris flows from Mt Cayley | | | | |

| Item | Monitor Description | Frequency |
|---|---|---|
| 1 | Monitor after heavy rains for washout given amount of debris transported by this system. | Routine Inspection |

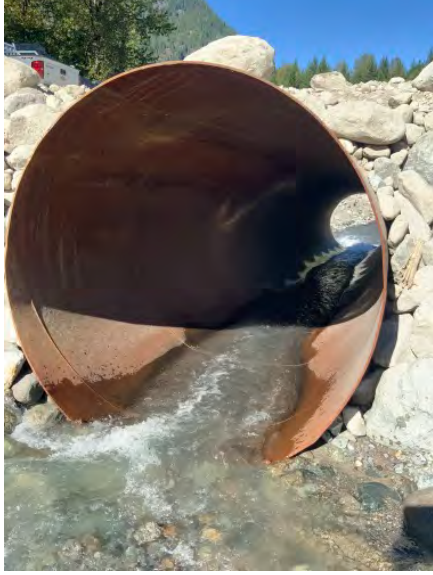
Inlet Good
