SQ-3162  
SQ-3162

ASHLU RIVER 35.8km

2020 Inspection

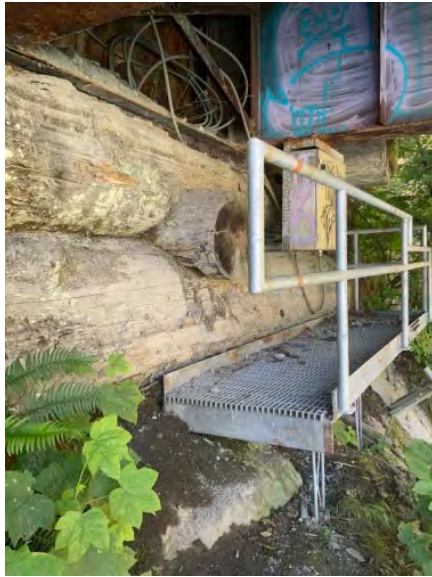
Right Bank Abutment when facing downstream

None on left side. Right side on bedrock and good.

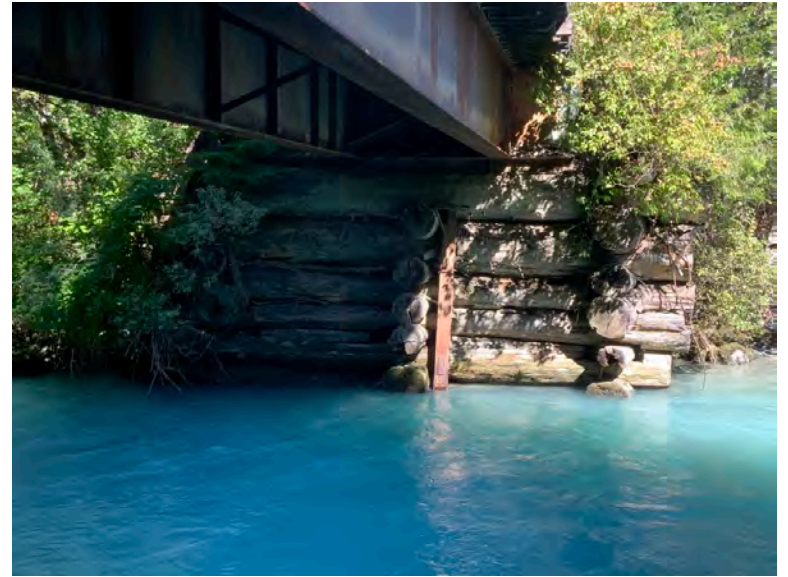
Left Bank Abutment when facing downstream

Can't reach crib to drill. Left side tie backs rotting and bottom log in water. It could easily wash away in a large rain event.

Rotting left side

Load Rated by: MFLNRORD, Greg Dohm, PEng., Jan. 7, 2021  
Load Rating: L100 or 91 tonnes  
Next Inspection: 2021  
Comments: Plan to replace bridge as town abutment is showing significant rot.

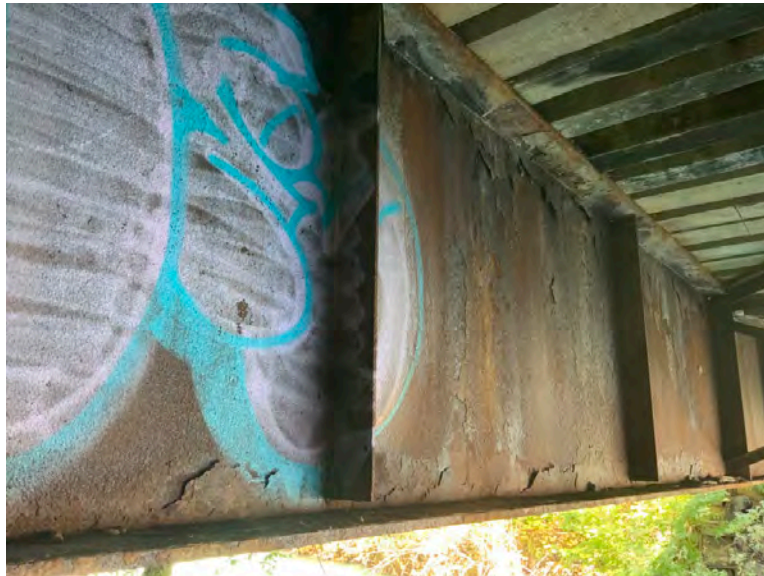
Stringers

| Item | Monitor Description | Frequency |
|---|---|---|
| 1 | Girders started to rust and delaminate | Routine Inspection |
