## SLOQUET CREEK MAIN 5.9km

2020 Inspection

| Crossing Name | North Sloquet Creek |

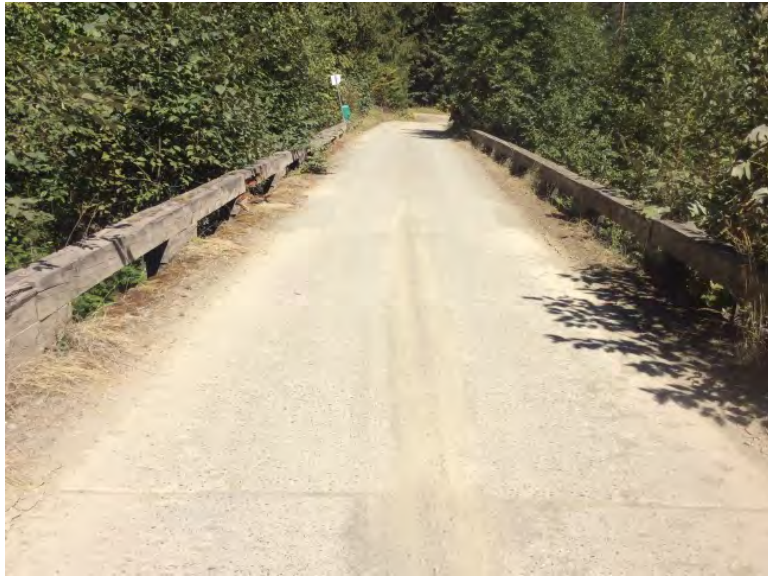
Overall Deck Condition      Poor      Curbs rails rotten and need replacing ASAP to keep bridge open

| Repair Item | Repair Description |
|---|---|
| 1 Structure. Full Curb Replacement. 1 .<br>Priority:High | Curbs rails rotten and need replacing ASAP to keep bridge open |

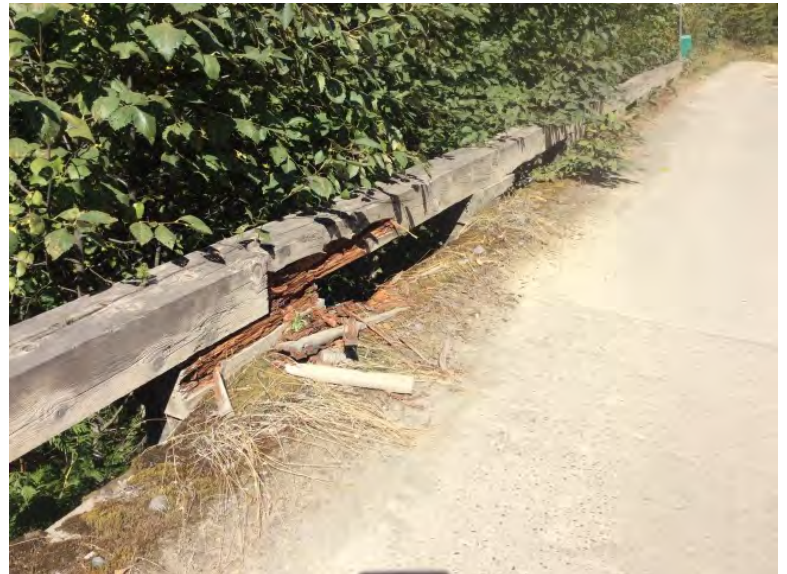
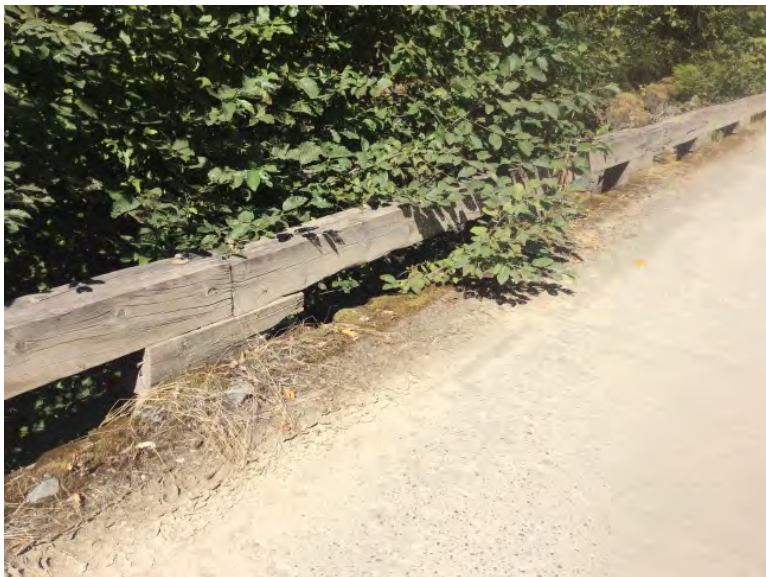
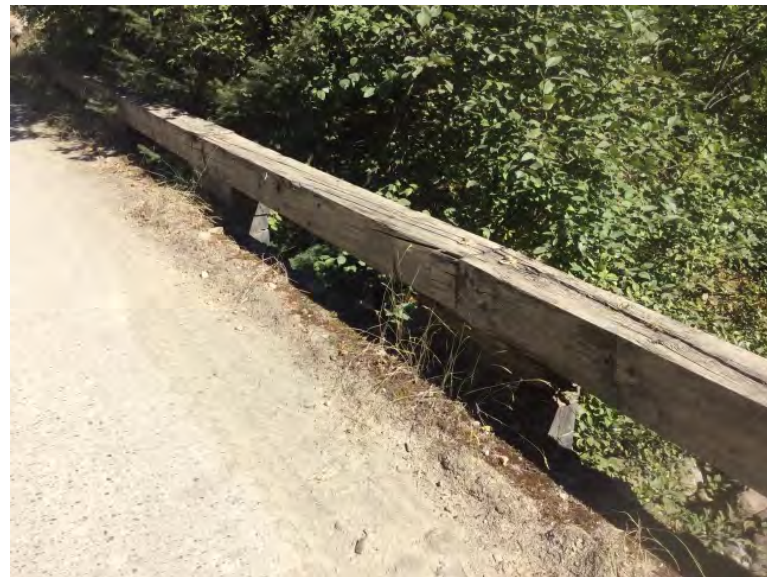
Guard Rail

Curb Rail/Blocks/Posts      Poor      Curbs rails rotten and need replacing ASAP to keep bridge open

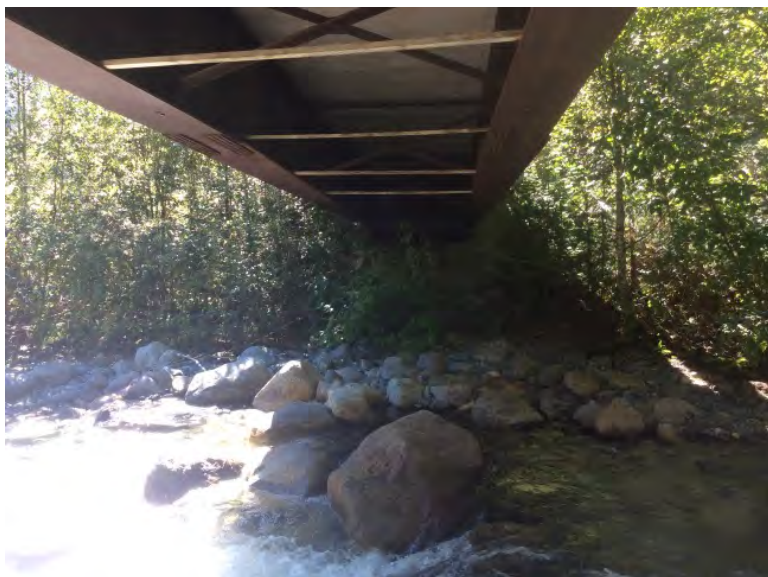
Right Bank Abutment when facing downstream

Riprap Poor Riprap Poor on townside — washed out with cobble deposits so appears still protected by natural deposition from upstream riprap wall effects

| Item | Monitor Description | Frequency |
|---|---|---|
| 1 | Riprap Poor on townside — washed out with cobble deposits so appears still protected by natural deposition from upstream riprap wall effects | Routine Inspection |
