SQ-3169  
SQ-3169

FURRY CREEK 03 0.5km

2020 Inspection

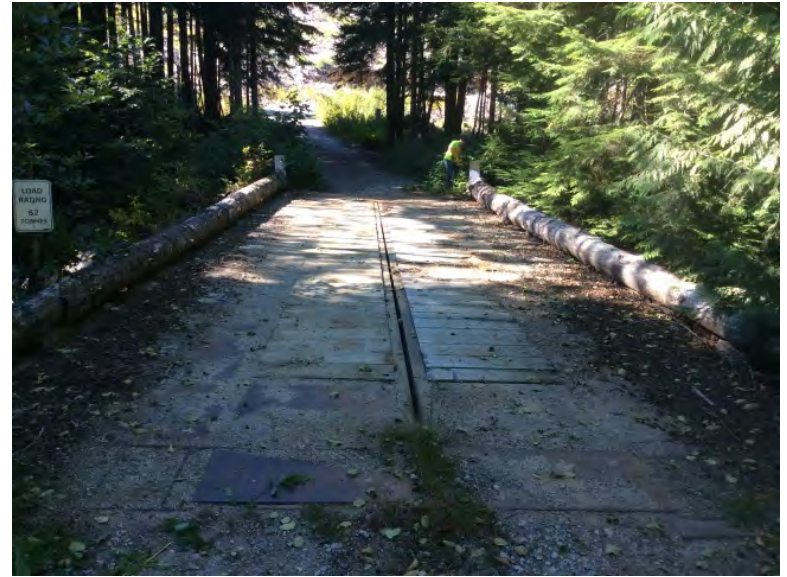
Deck has unconventional 2" thick planks over corroding steel transverse purlins. Needs proper timber tie deck. Load rating to be down rated.

Running Planks Poor unconventional 2" thick planks over corroding steel transverse purlins. Needs proper timber tie deck. Load rating to be down rated.

Replace deck with timber deck

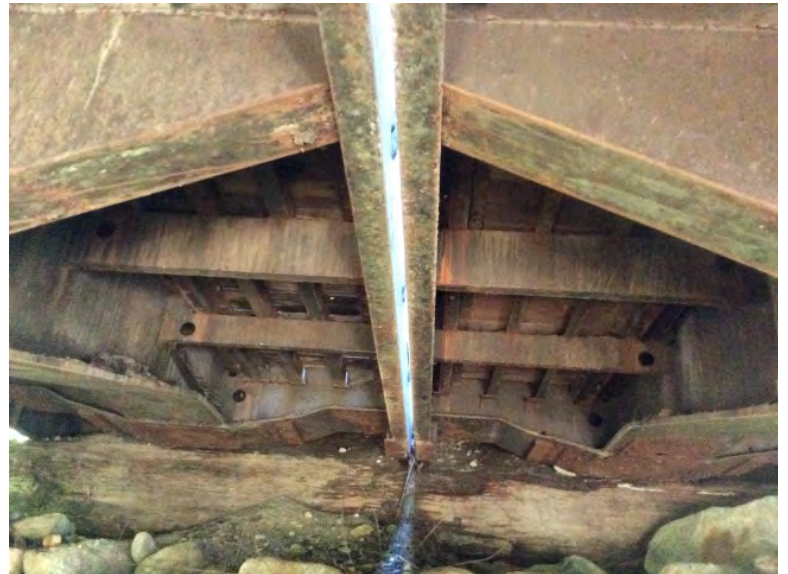
Superstructure

Corrosion Protection Poor Aging rail car
