SQ-3174  
SQ-3174

## CHEAKAMUS/BLACKTUSK

2020 Inspection

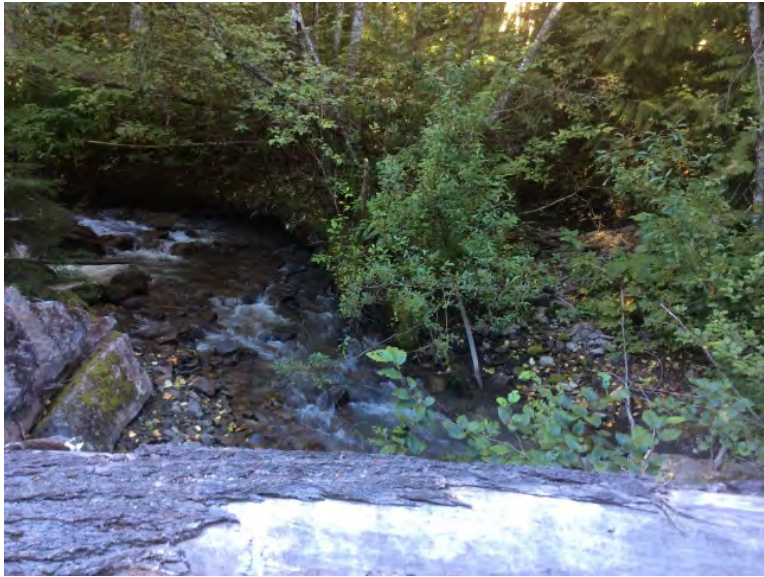
Upstream from Crossing

| Comments | Shifting upstream stream channel. | | | | |

| Item | Monitor Description | Frequency |
|---|---|---|
| 1 | Appears upstream channel shifted and created two branches into the stream just upstream of the bridge. However, just new branch is flowing. Check with historical photos. Check change at next inspection. | Routine Inspection |
