SQ-3176  
SQ-3176

LILLOOET RIVER 01 35.3km

2020 Inspection

| Crossing Name | Alena Creek |

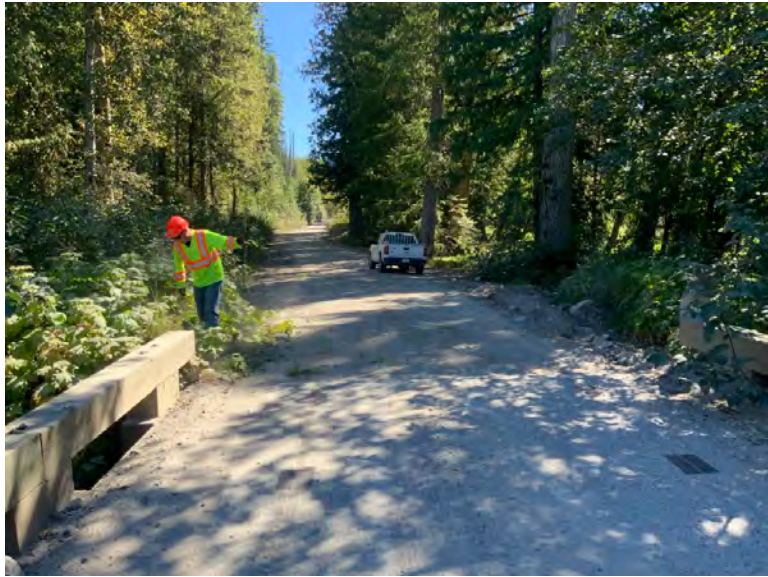
Approach from Left Bank when facing downstream

Fender Condition Poor Missing on all corners

| Repair Item | Repair Description |
|---|---|
| 1 Approach. Approach fenders (install). # of units. Priority:Medium | Add approach barriers on all corners |

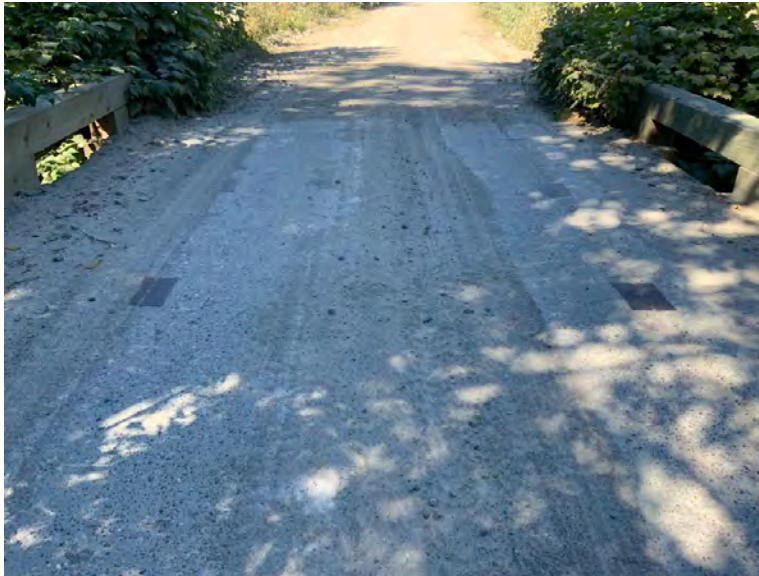
Overall Deck Condition      Good
