SQ-3183  
SQ-3183

FURRY CREEK 01 0.3km

2020 Inspection

Crossing Name Tributary to Furry Creek

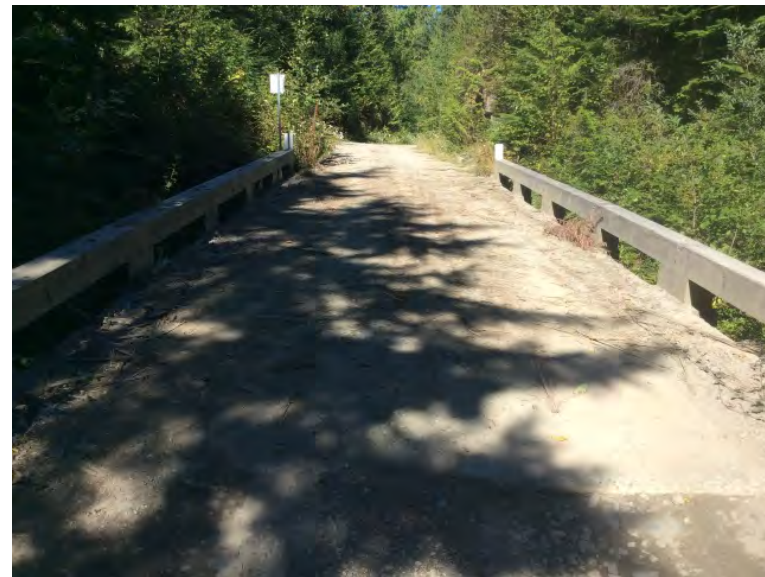
Overall Deck Condition      Fair      Excerpt needs cleaning

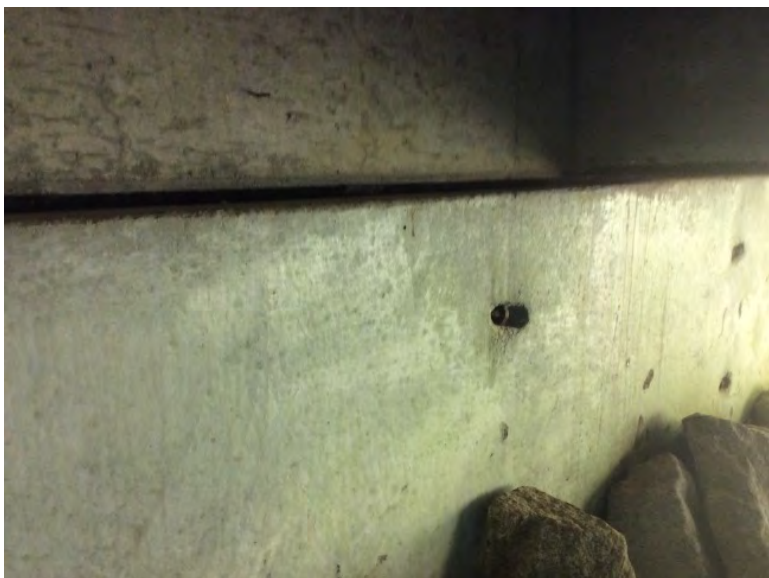
Bearing

Bearings Fair
