SQ-3184  
SQ-3184

## SQUAMISH RIVER 35.5km

2020 Inspection

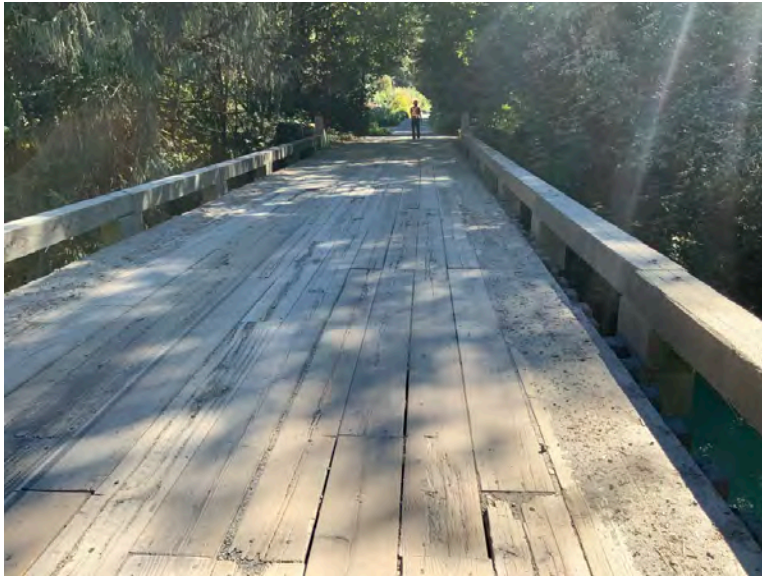
Comments: cross-ties getting old and may be deteriorating indicated by planks lifting. Plan to replace deck in relatively near future.

| Ties | Poor | 8x12 treated 400 c/c. Deck boards moving up and down with traffic. Nails starting to get loose. |
| Nails | Poor | Deck boards moving up and down with traffic. Nails8x12 treated 400 c/c. Deck boards moving up and down with traffic. Nails starting to get loose. starting to get loose. |

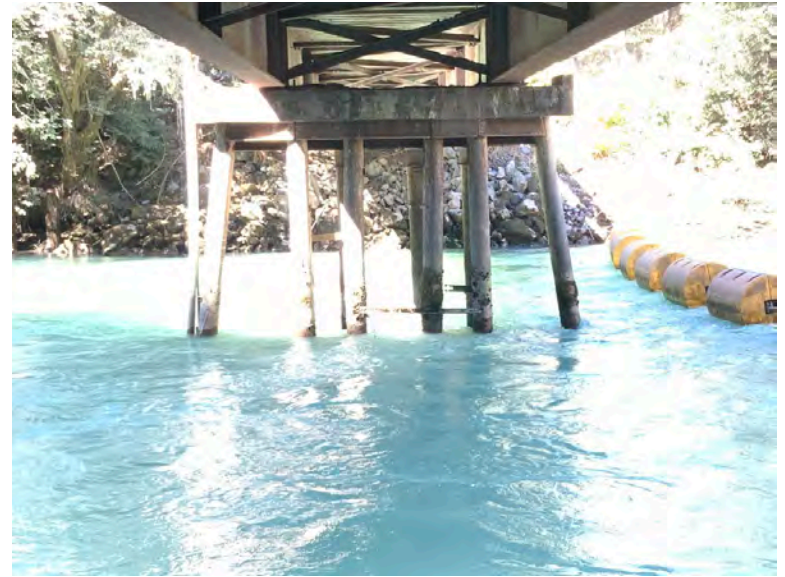
Pier Fair
