SQ-3205  
SQ-3205

## SLOQUET CREEK MAIN 12km

2020 Inspection

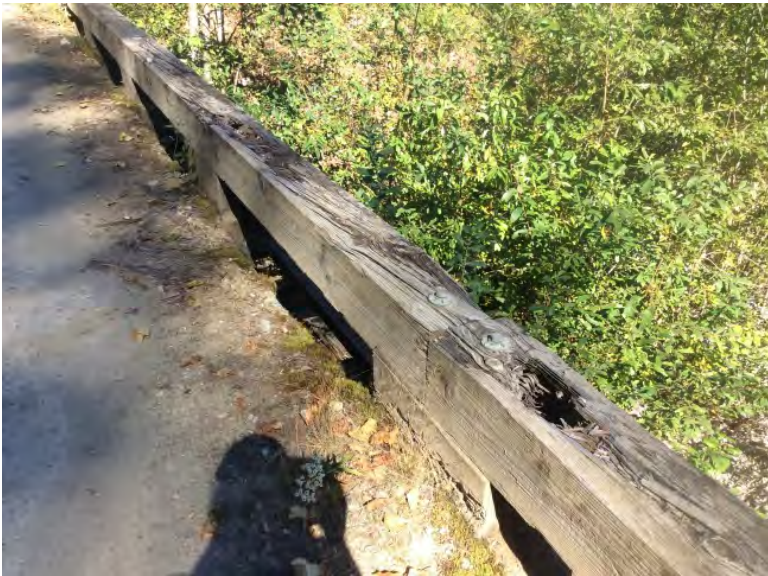
Guard Rail

Curb Blocks ok but curb rails poor and need replacing ASAP for continued use.

Curb Rail/Blocks/Posts      Poor      Curb Blocks ok but curb rails poor and need replacing

Load Rated by: MFLNRORD, Greg Dohm, PEng., Jan. 11, 2021  
Load Rating: L75 or 68 tonnes  
Next Inspection: 2021  
Comments: Replace curb rails asap for continued use.

| Repair Item | Repair Description |
|---|---|
| 1 Structure. . 1 . Priority:High | Curb Blocks ok but curb rails poor and need replacing |
