SQ-3213  
SQ-3213

SQ\_MAM1000 2km

2020 Inspection

Crossing Name Trib to Mamquam River

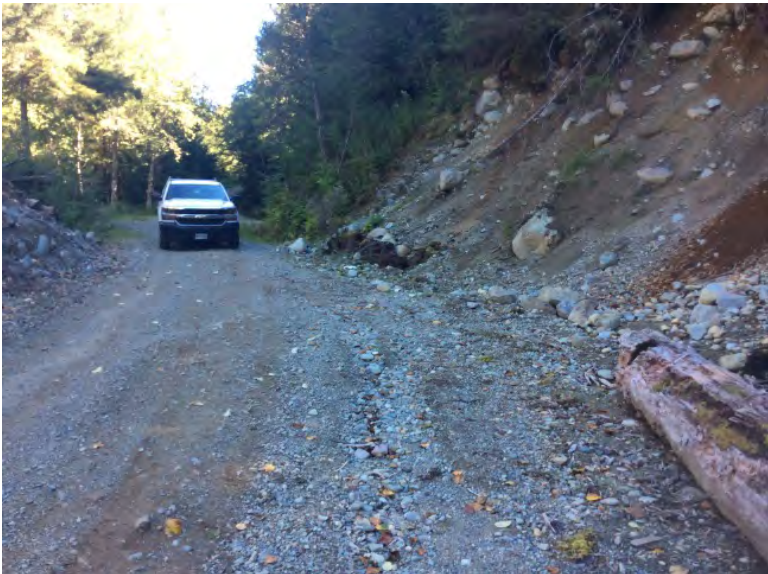
Approach from Left Bank when facing downstream — ditch line needs redefining as is eroded no road surface on woods side

| Repair Item | Repair Description |
|---|---|
| 1 Approach. Surface drainage maintenance (drains, catch basins, ditches). 1 # of | Approach from Left Bank when facing downstream — ditch line needs redefining as is eroded and needs redefining |

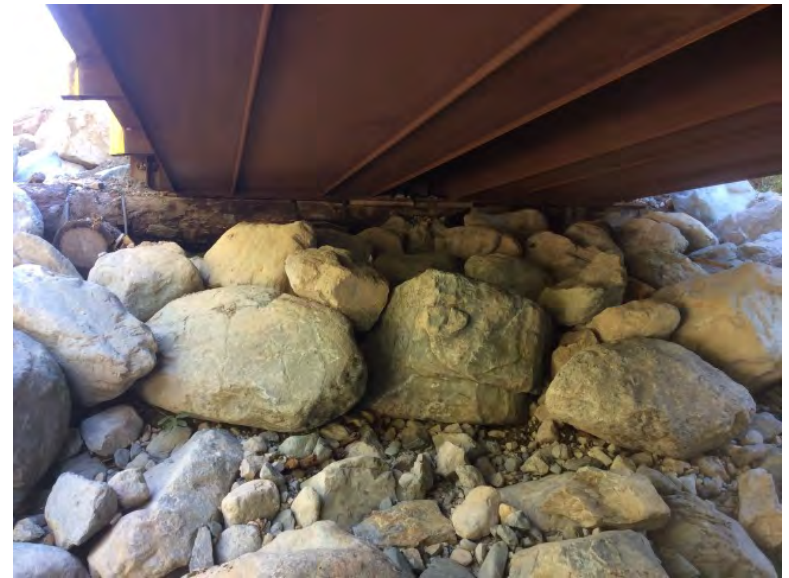
Right Bank Abutment when facing downstream

Caps or Sills Poor Sills at both abutments shimmed and not bearing along full length

| Repair Item | Repair Description |
|---|---|
| 2 Substructure. Timber caps and log sills. 1 m². Priority:Medium | Sills at both abutments shimmed and not bearing along full length. Superstructure should be removed and sills recut level along sill bearing surfaces to achieve full bearing. |

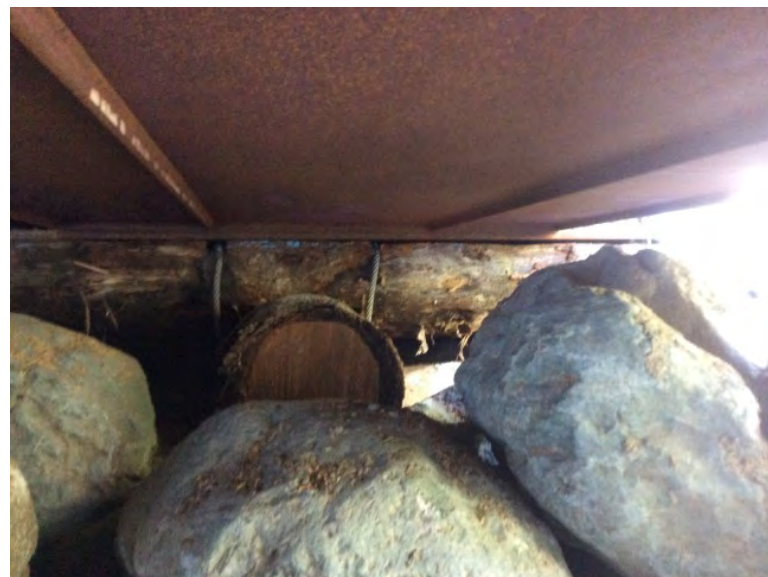
Bearing - townside

Bearings Poor Sills at both abutments shimmed and not bearing along full length
