SQ-3234  
SQ-3234-A

LILLOOET WEST 02 57.4km

2020 Inspection

| Crossing Name | Trib to Lillooet Lake |

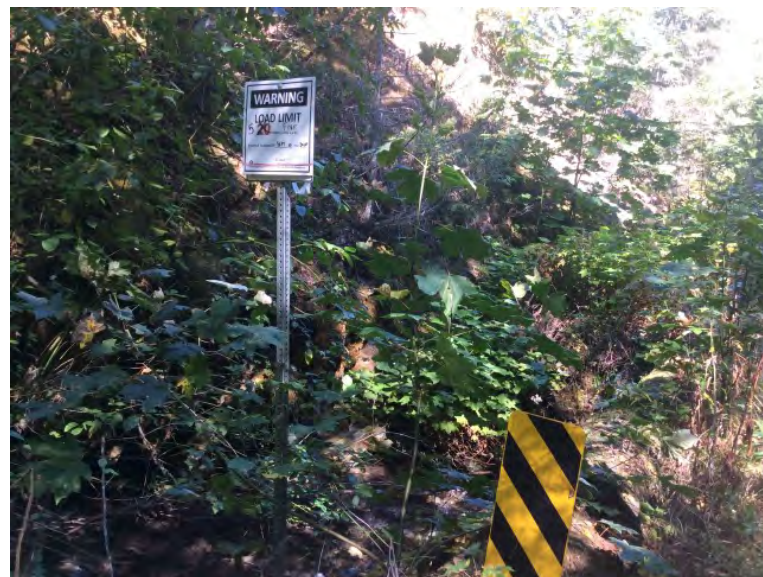
Load Rating Sign

Posted Load Rating 20 Changed to 5 tonnes during inspection
