SQ-3248  
TCH-1203

SQ\_MAM1000 0.4km

2020 Inspection

Crossing Name Trib to Mamquam River  
FSR # 9283 Branch # 6

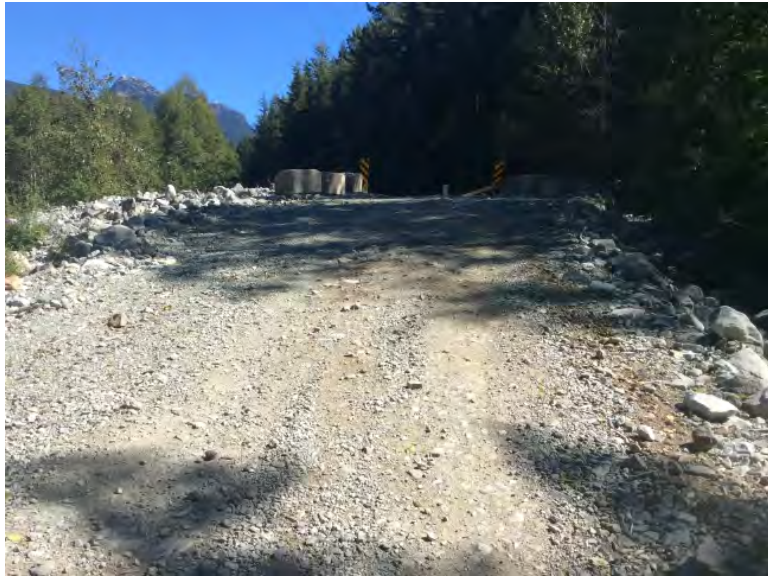
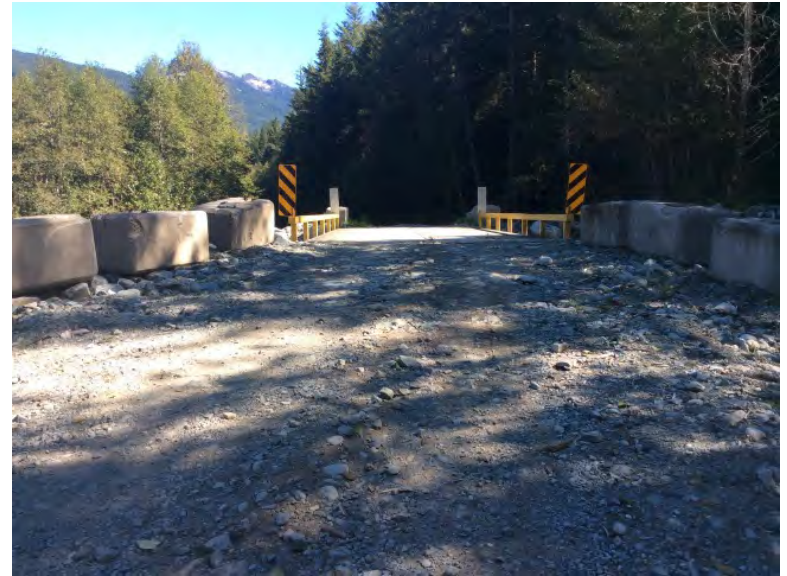
Approach from Left Bank when facing downstream

Very steep approaches on debris fan

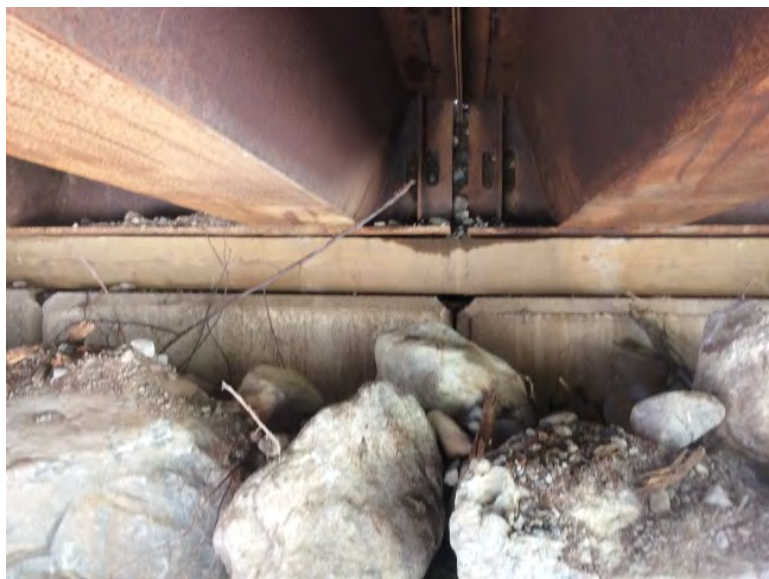
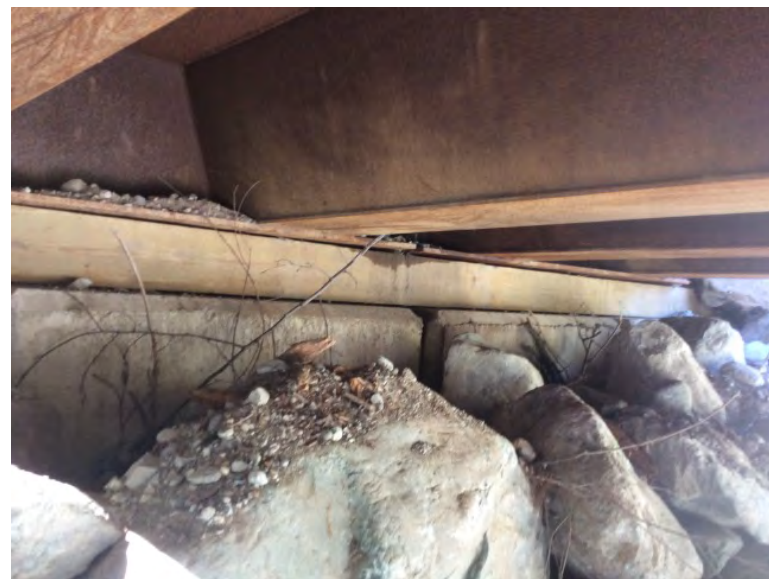
Left Bank Abutment when facing downstream

Both townside and woodside sills not level and bridge not bearing fully. Should be removed and reinstalled.

Sills at both abutments shimmed and not bearing along full length. Superstructure should be removed and sills recut level along sill bearing surfaces to achieve full bearing.

| Repair Item | Repair Description |
|---|---|
| 1 Substructure. Timber caps and log sills. 1 m <sup>2</sup> .<br>Priority:Medium | Sills at both abutments shimmed and not bearing along full length. Superstructure should be removed and sills recut level along sill bearing surfaces to achieve full bearing. |
