## STAWAMUS-INDIAN MAIN

2021 Inspection

| Crossing Name | Indian River |

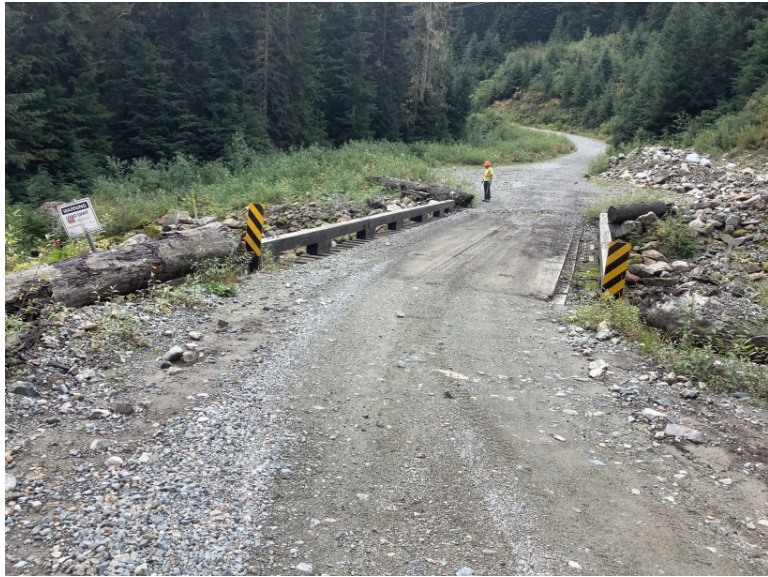
Approach from Left Bank when facing downstream

Woods side fender pushed into lane. Needs to be moved

1 Approach. Approach  
fenders (re-Install). 1 # of  
units. Priority:Low
