SQ-3021

HAYLMORE CREEK MAIN 16.2km

2021 Inspection

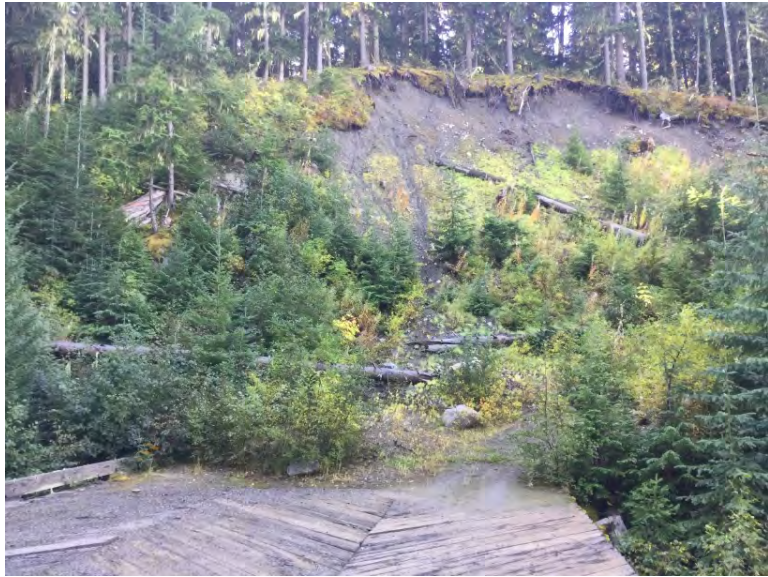
Approach from Left Bank when facing downstream

Alignment Poor

Very sharp turn

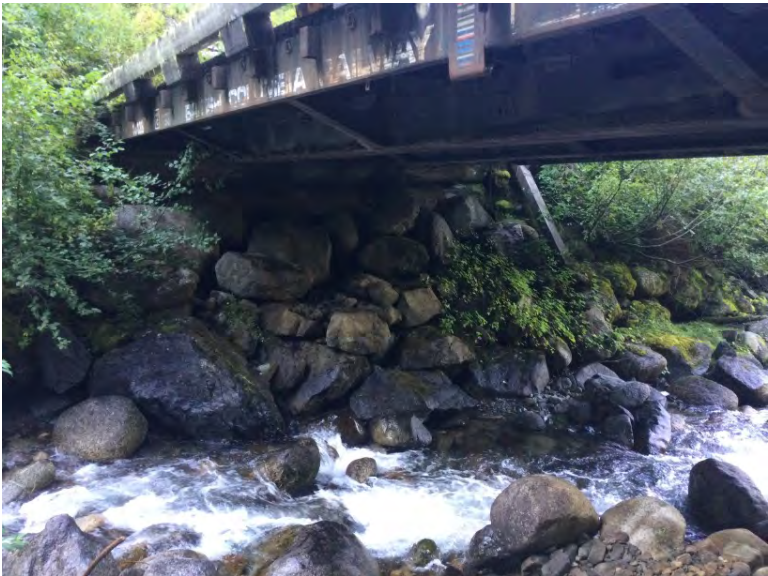
Left Bank Abutment when facing downstream

Log/Timber Cribs Fair

Tie Backs Fair

Caps or Sills Fair

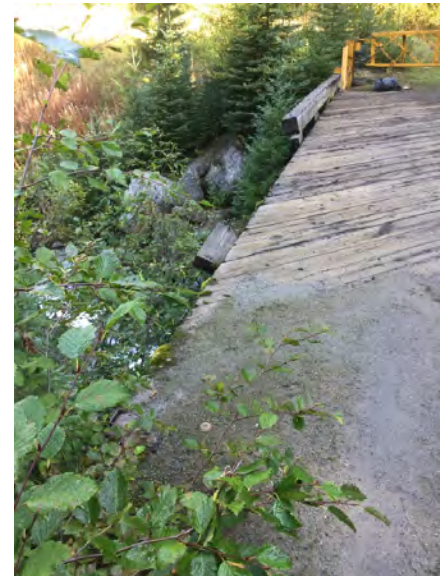
Guard Rail

Major deck and guard rail issues. Bridge to remain closed.

| Curb Rail/Blocks/Posts | Poor | Rotten and missing |

| Item | Priority | Repair Description |
|---|---|---|
| 1 | High | Replace deck with timber tie and plank deck with curb rails prior to use. |

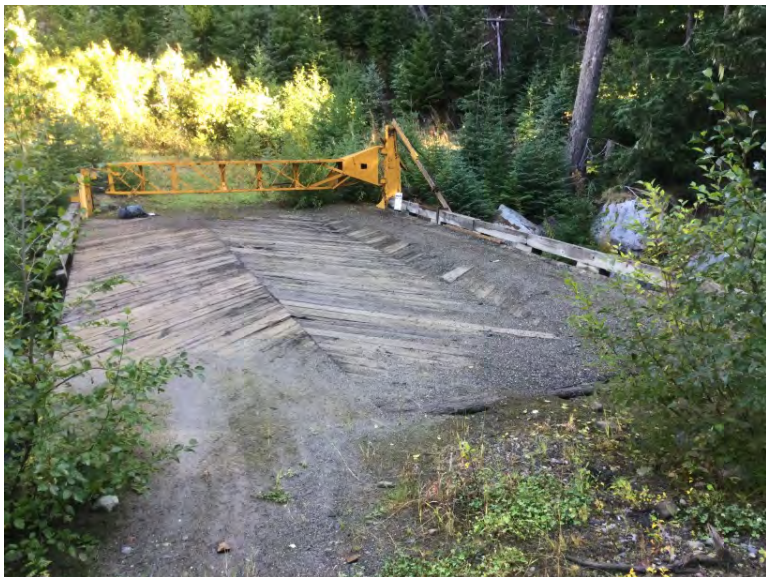
| Running Surface | Poor | Holes in deck and bank sloughed in |

| Running Planks | Poor | Rotten |

| Overall Deck Condition | Poor | Condemned deck |

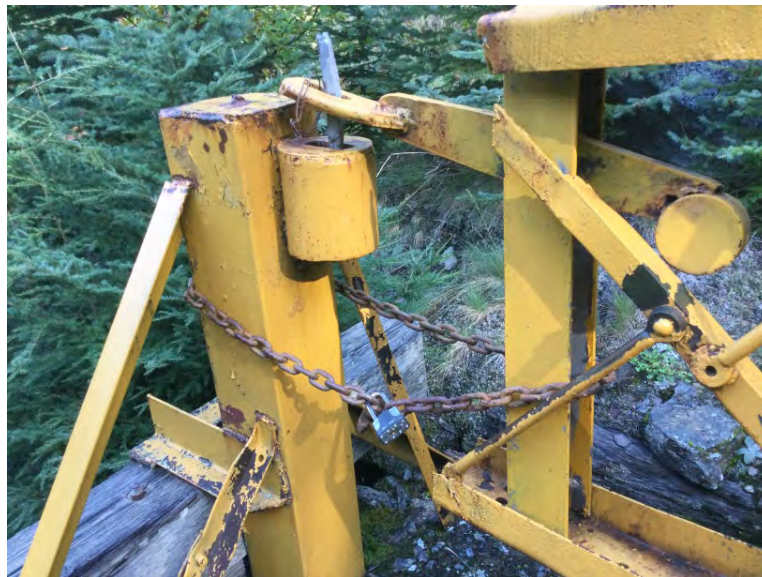
Locked gate

Bridge currently inaccessible to vehicles, ATV possible. Bridge gate was found closed, put lock with chain and forestry lock once leaving site.
