SQ-3031  
SQ-3031

CALLAGHAN 01 5.9km

2021 Inspection

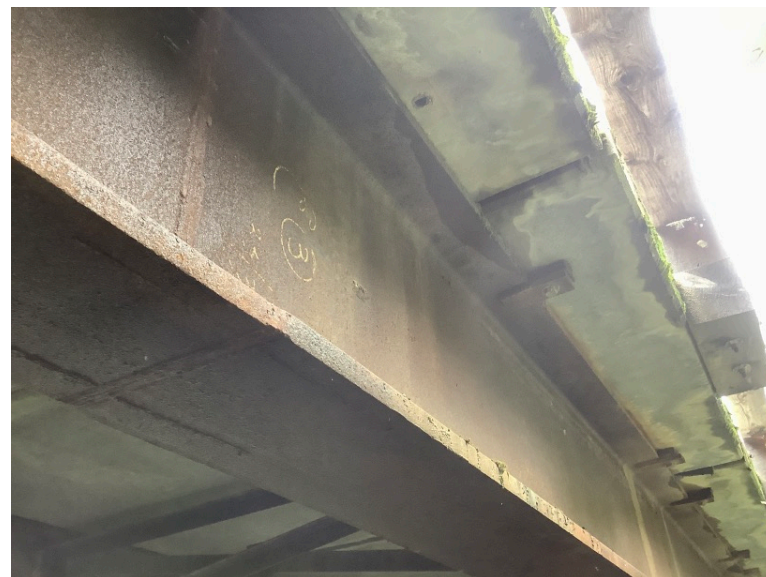
Deck to Girder Bolts      Fair      Missing one deck clip and bolt on upstream side

Deck - missing deck bolt and plate

| Repair Item | Repair Description |
|---|---|
| 1 Structure. Concrete structural maintenance. 1 m <sup>2</sup> . Priority:Medium | Missing deck bolt, plate and spacer on upstream girder |
