SQ-3032  
SQ-3032

CALLAGHAN 01 8.2km

2021 Inspection

Crossing Name Madley Creek

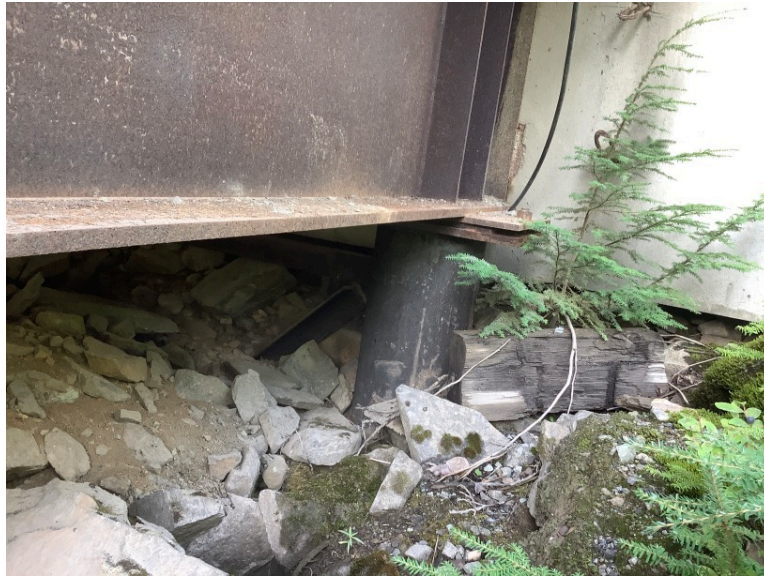
Bearing

Bearings Fair
