SQ-3044  
SQ-3044

LILLOOET RIVER 01 10.4km

2021 Inspection

Crossing Name Sampson Creek

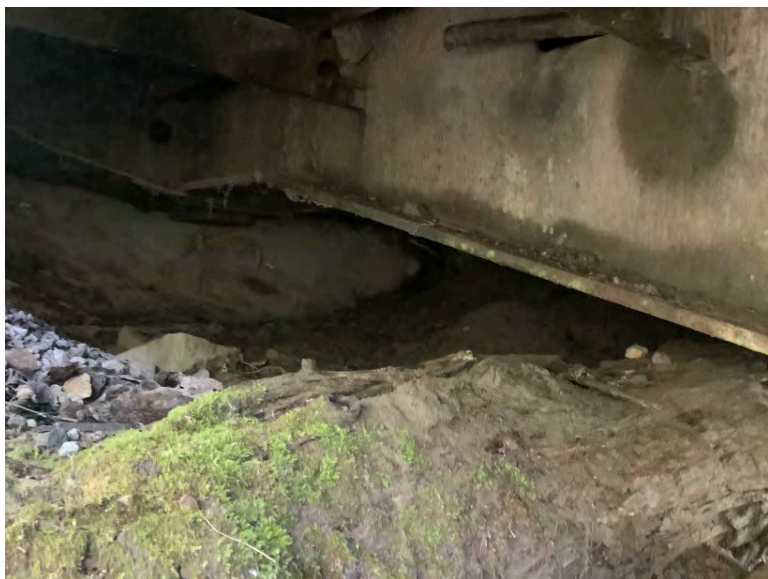
Tie Backs Poor Poor on wood side. Bearing is set on sill log behind abutments
