SQ-3052  
SQ-3052

## BROHM RIDGE 0.1km

2021 Inspection

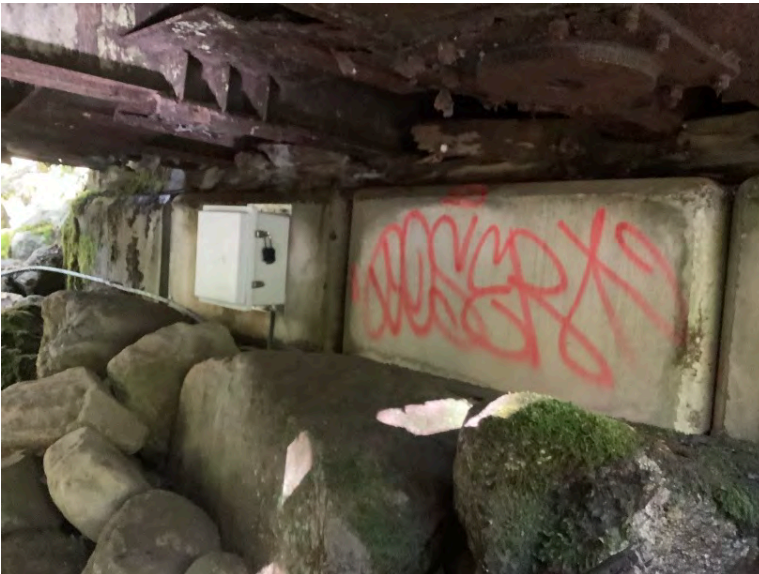
Left Bank Abutment when facing downstream

Left bank abutment wood sill has been crushed - see photos. Replace bridge. For short term continue with current load rating. Bearings areas on woods side appear undersized.

Comments: Woods abutment timber sill is crushed however still functioning allowing current load rating to continue. Plan to replace bridge or upgrade bearings. To reuse the existing twin rail car superstructure it may be possible replace the timber sills with an engineered steel bearing beam or precast bearing beam with steel bearing plate set on grout bed on the existing lock blocks.

Bearings Poor Left bank abutment wood sill has been crushed - see photos

| Repair Item | Repair Description |
|---|---|
| 1 Substructure. Timber caps and log sills. 1 m <sup>2</sup> .<br>Priority:High | Left bank abutment wood sill has been crushed - see photos. Replace bridge. |
