SQ-3056  
SQ-3056

IN-SHUCK-CH FSR 0.3km

2021 Inspection

| Crossing Name | Joffre Creek |

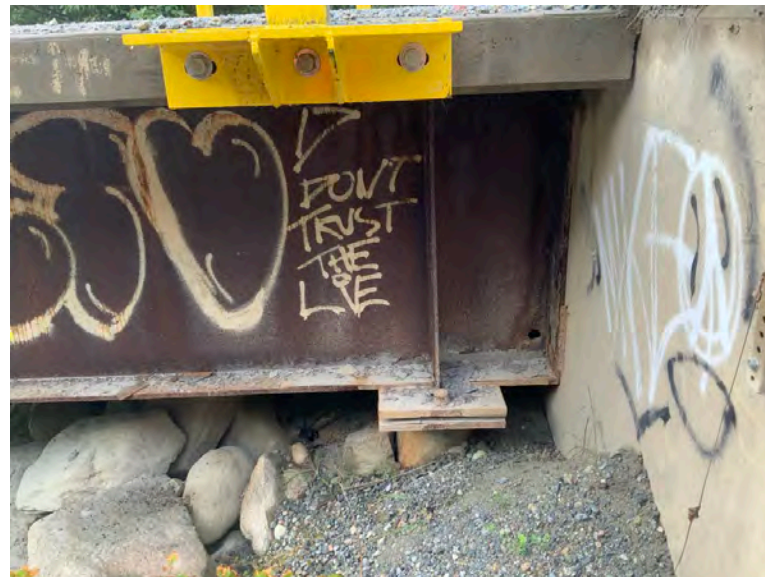
Bearing

Bearings Fair Corrosion

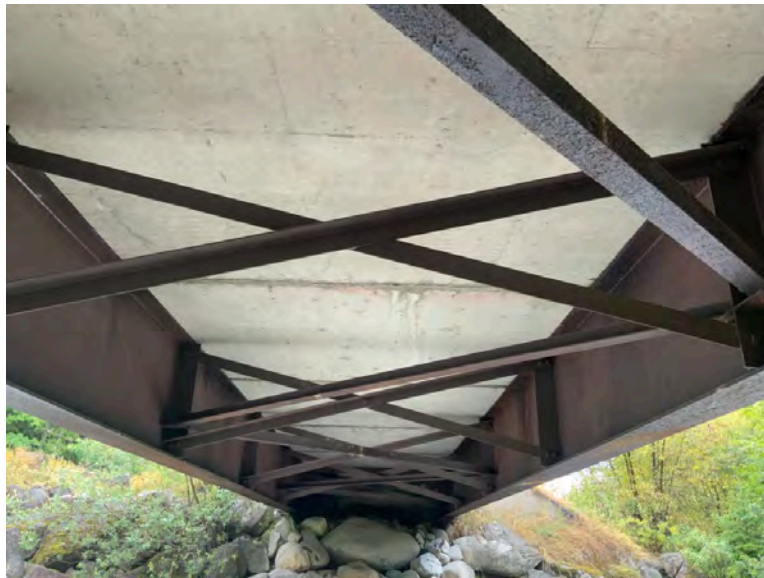
Superstructure

Girders Fair Steel components rusting and peeling

| Item | Monitor Description | Frequency |
|---|---|---|
| 1 | Steel components for further corrosion | Routine Inspection |
