SQ-3060  
SQ-3060

IN-SHUCK-CH FSR 14.9km

2021 Inspection

Crossing Name Lizzie Creek North

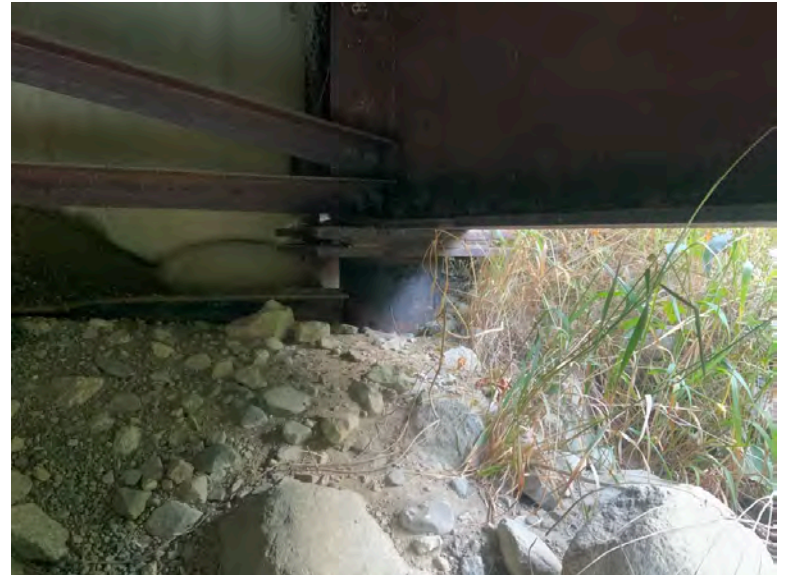
Bearing

Bearings Fair
