SQ-3077  
SQ-3077

2021 Inspection

Crossing Name Sixteen Mile Creek

FSR # 7910 Branch # 3

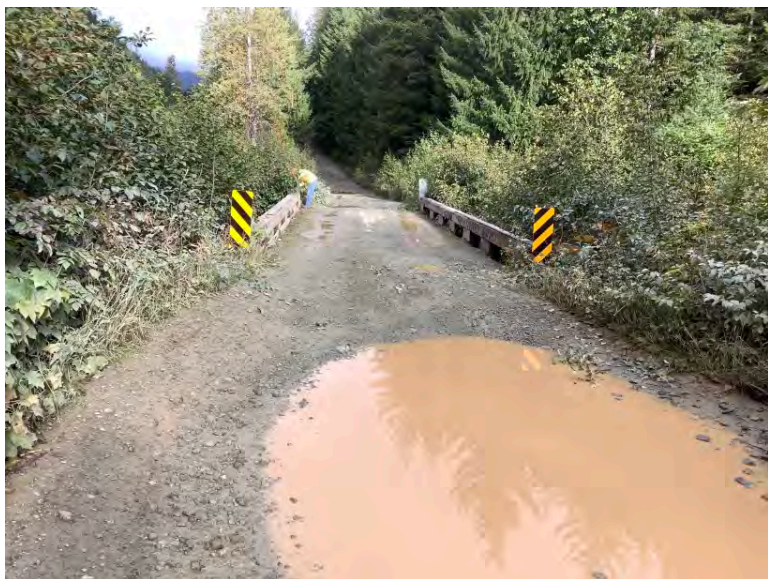
Approach from Right Bank when facing downstream

Road Surface Poor Lots of large pot holes

| Repair Item | Repair Description |
|---|---|
| 2 Approach. Approach surfacing grading. 1 m.<br>Priority:Low | Fill and grade pot holes |

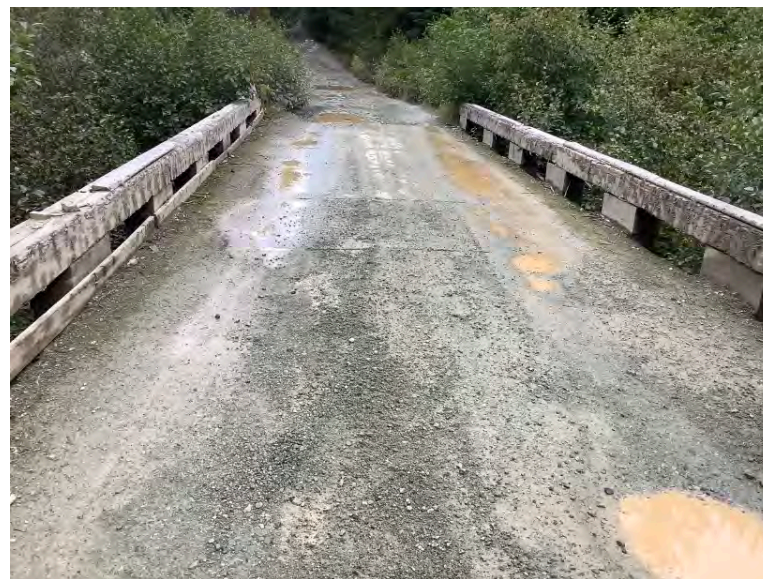
Running Surface      Fair      Lots of large pot holes

Deck Joints      Poor      Should be sealed to limit sediment into stream

Overall Deck Condition      Fair

| Repair Item | Repair Description |
|---|---|
| 1 Structure. Joint replacement. 1 m².<br>Priority:Low | Slab joints should be sealed |
