SQ-3081  
SQ-3081

ROGERS 01 9km

2021 Inspection

| Crossing Name | Trib to Rogers Creek |

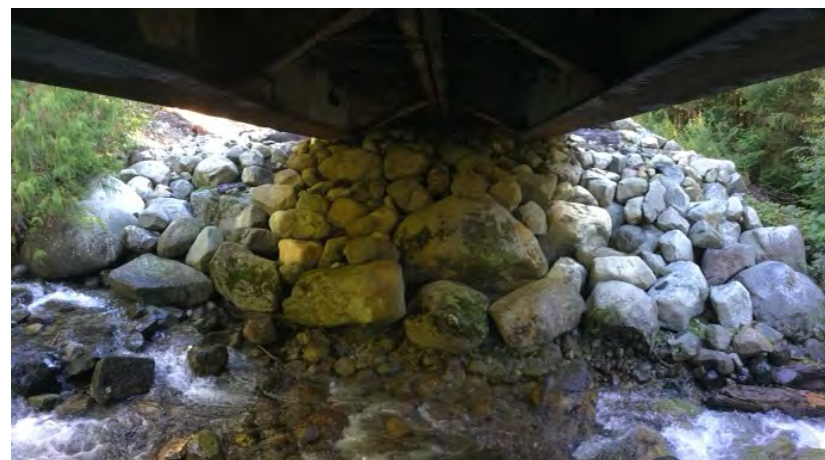
Left Bank Abutment when facing downstream

Riprap **Fair** Some erosion under first row of riprap on woods side. No change since last inspection

| Item | Monitor Description | Frequency |
|---|---|---|
| 1 | Erosion on left side to be monitored under first row of riprap | Routine Inspection |
