SQ-3083  
SQ-3083

LILLOOET SOUTH 01 3.5km

2021 Inspection

| Structure Class | Temporary Bridge |

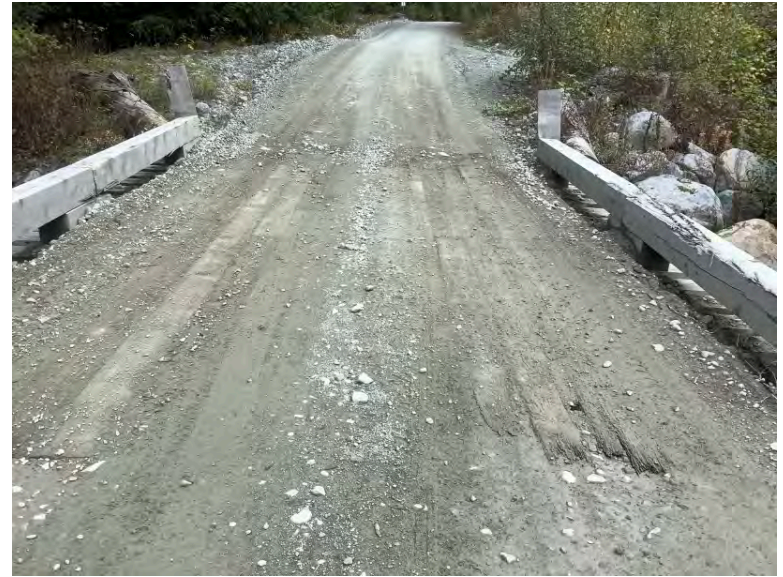
Deck

Ties Fair Conk on cross ties. Drilled and lots of rot found.

Conk on cross ties. Drilled and lots of rot found. Timber cross ties to be replaced. Downrate bridge load rating to 20 tonne GVW.
